Inspection Report

**New Mexico
Homebuyer**

Property Address:
1234 Camino St.
Las Cruces NM 88001

Date: 4/20/2022	Time: 08:35 AM	Report ID: Sample
Property: Las Cruces NM 88011	Customer: NM Homebuyer	Real Estate Professional: Best in LC

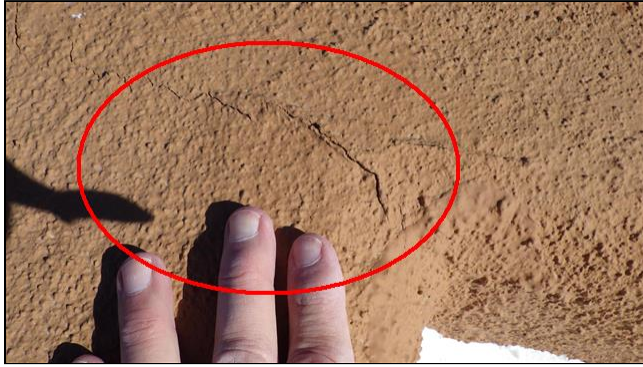
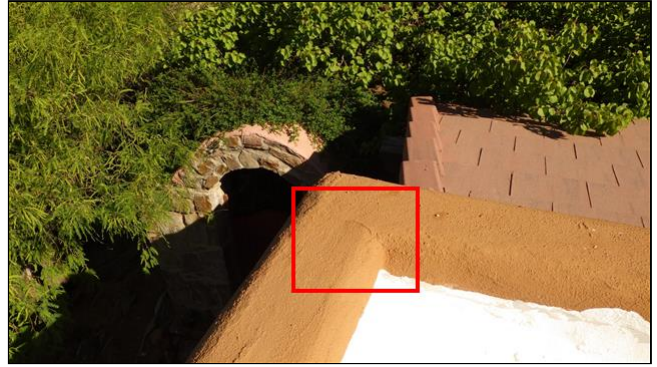
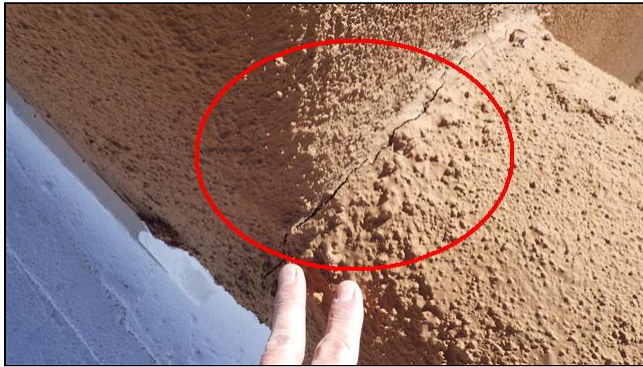
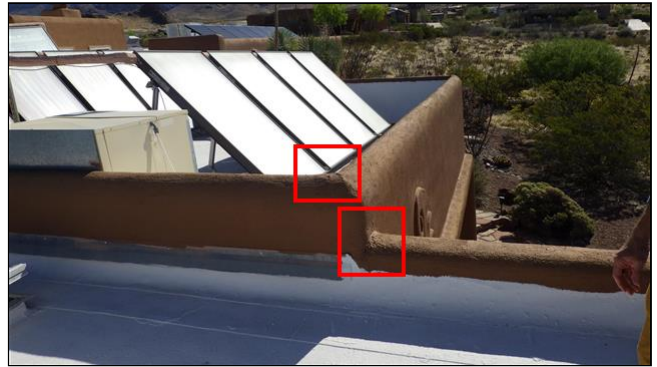
The stucco covered cap is cracked and or incomplete exposing underlying wall SYSTEM COMPONENTS (noted at limited corner areas). ACTION RECOMMENDED by a QUALIFIED stucco contractor.

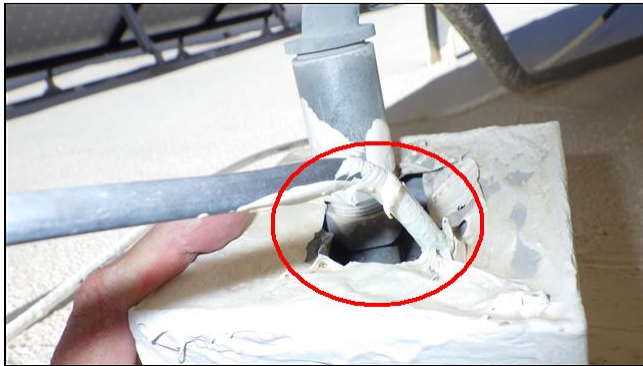
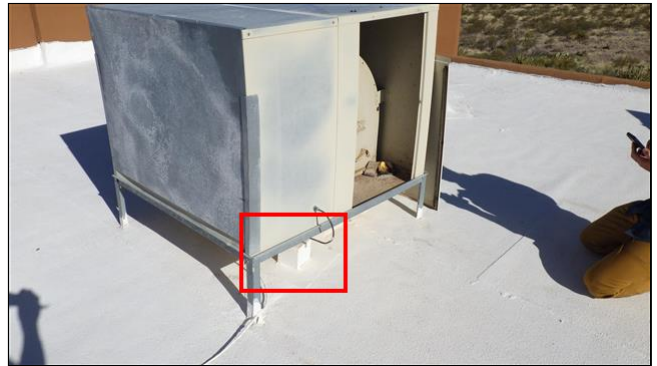
The tar pot penetrations are gapped and or cracking (noted below the east evaporative cooler). ACTION RECOMMENDED by a QUALIFIED roofing contractor.

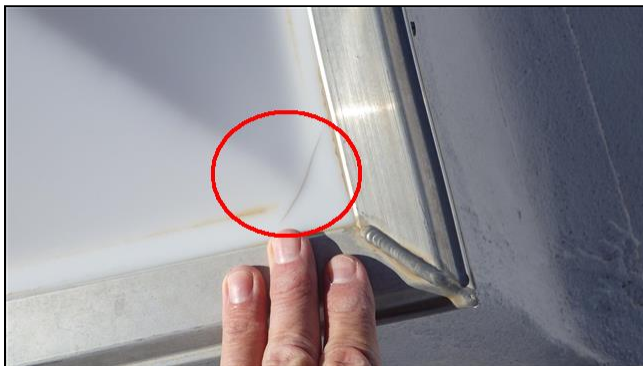
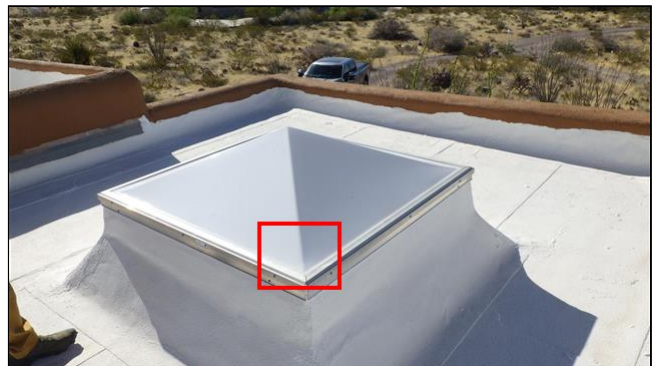
Exterior plastic lens of dual glazed skylights are fractured (noted near the solar water heating panels and above the kitchen). ACTION RECOMMENDED by a QUALIFIED roofing contractor.

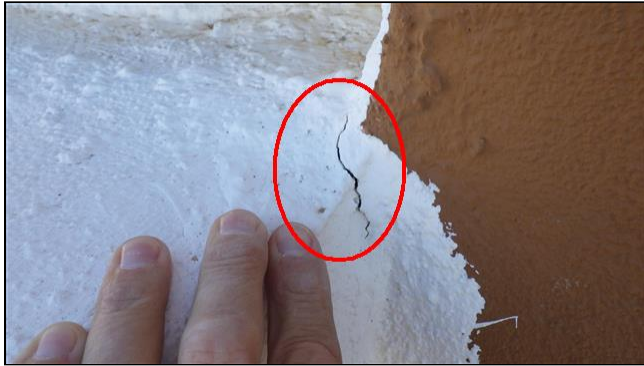
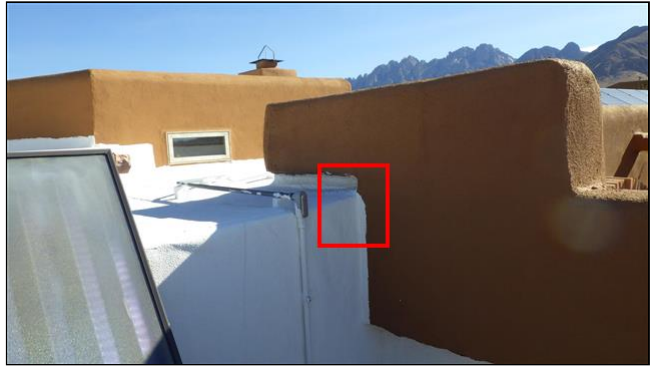
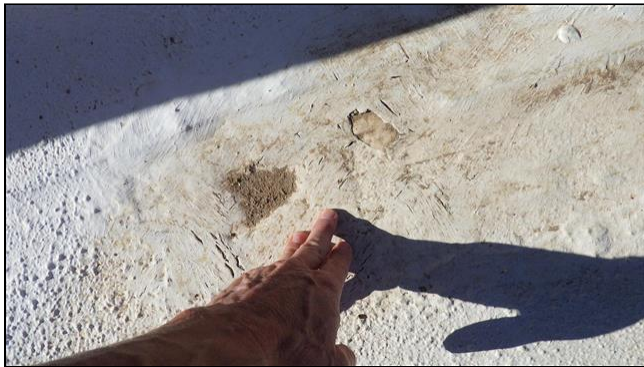
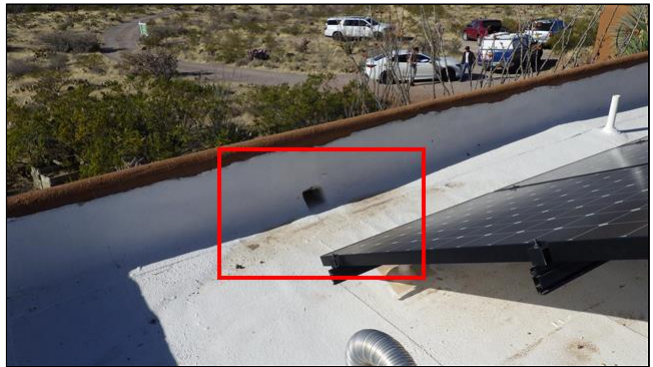
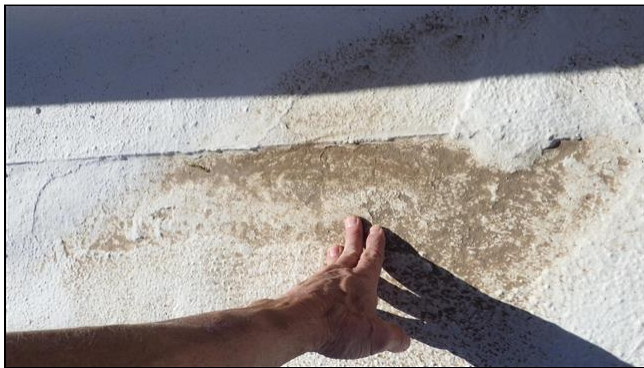
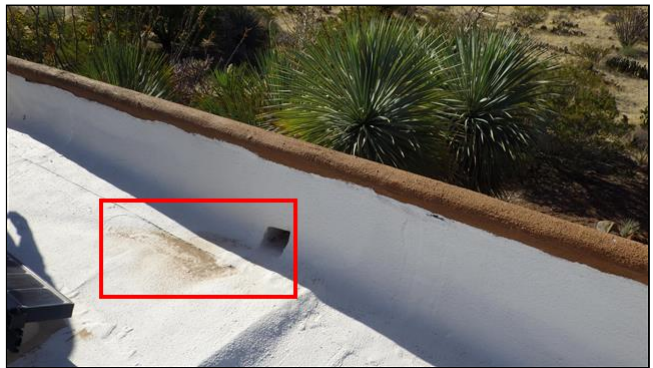
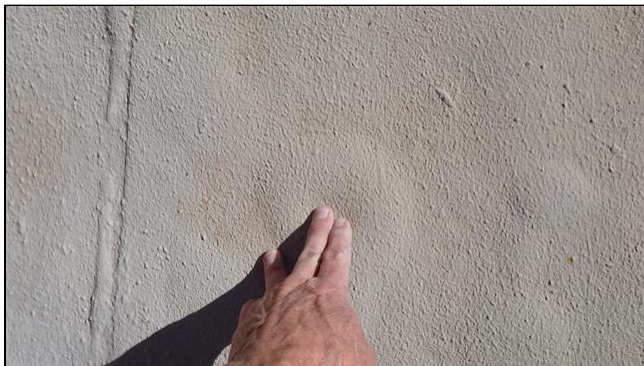
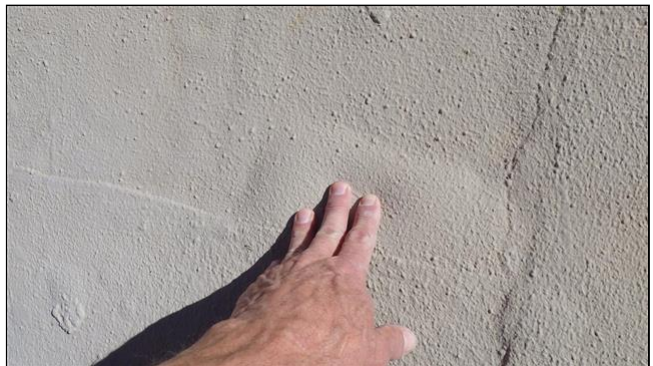
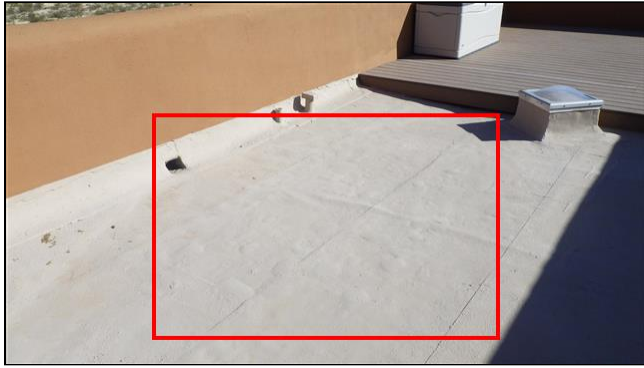
The cap sheet roof surface and elastomeric coating includes areas with exposed seams, cracking and or blistering on the surfaces (noted at the roof elevation change between the garage and laundry area, at collection areas adjacent to scuppers along the front roof area and at the tan coated section next to the walk up deck). Further EXAMINATION and ACTION RECOMMENDED as deemed necessary by a QUALIFIED roofing contractor.

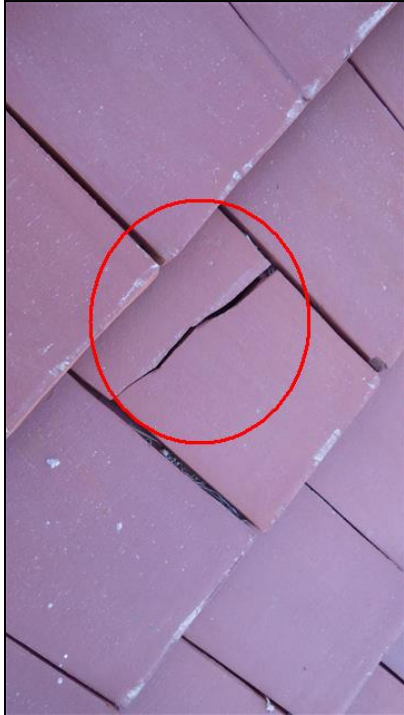
Tiles or mortar are cracked and or loose (noted at limited areas on the clay tile patio roof). ACTION RECOMMENDED by a QUALIFIED roofing contractor.

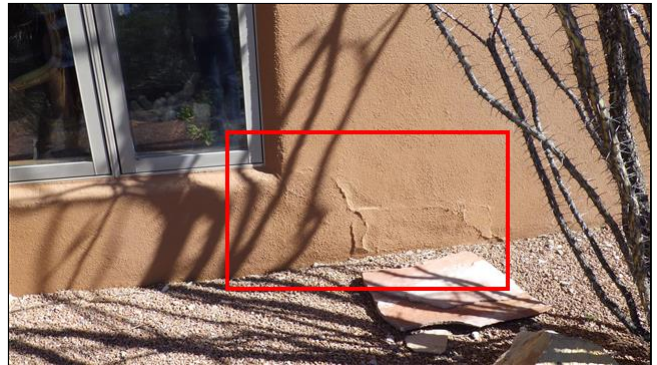
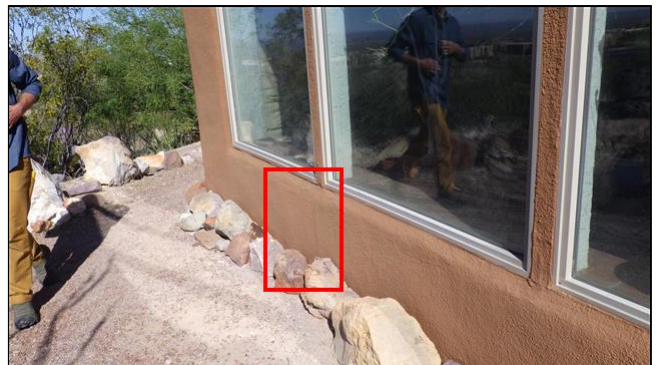
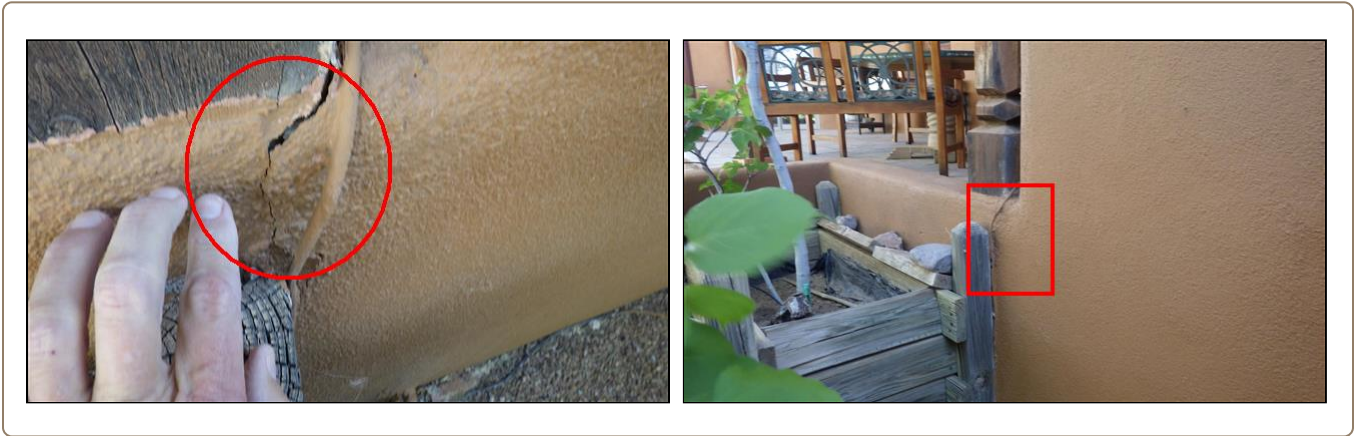
There are cracks in the stucco at corners, control joints and or adjacent to windows and doors. All stucco covered wall areas should have further EXAMINATION and ACTION RECOMMENDED as deemed necessary by a QUALIFIED stucco contractor.

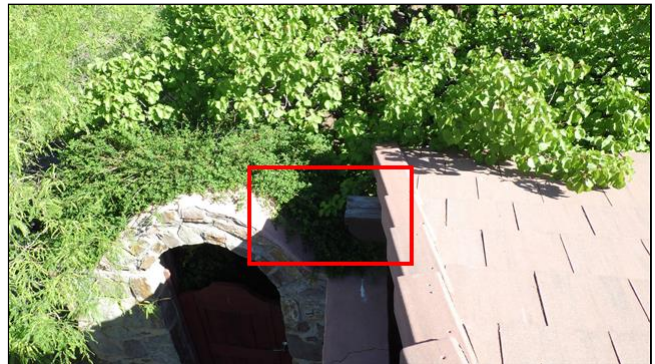
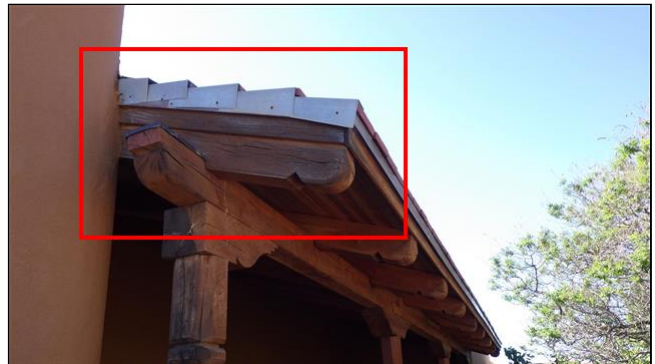
(1) Weathered wood surfaces at posts and beams (noted at exposed wood areas for each patio) should be serviced to be sealed and or moisture protected. ACTION RECOMMENDED by a QUALIFIED painter

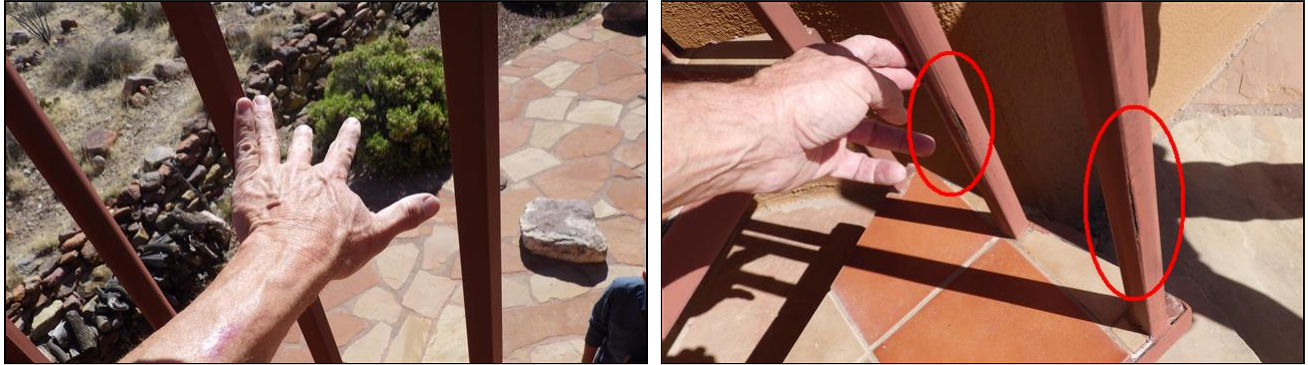
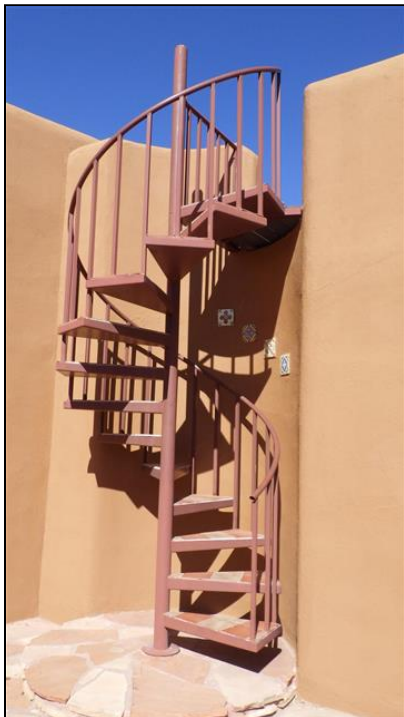
(2) Rails and or balusters at stairs, balconies and or decks have IMPROPER wide spacing and can allow a small child to pass through (noted at the spiral stair set).

Metal stair set COMPONENTS are rusted out and or damaged (noted at a number of baluster/ stiles on the spiral stair set).

ACTION RECOMMENDED by a QUALIFIED metal fabricator.

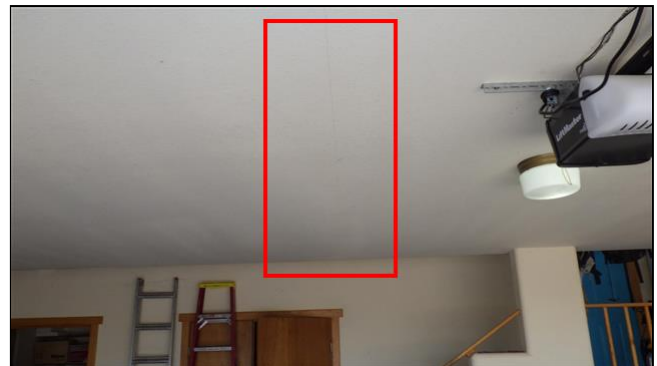
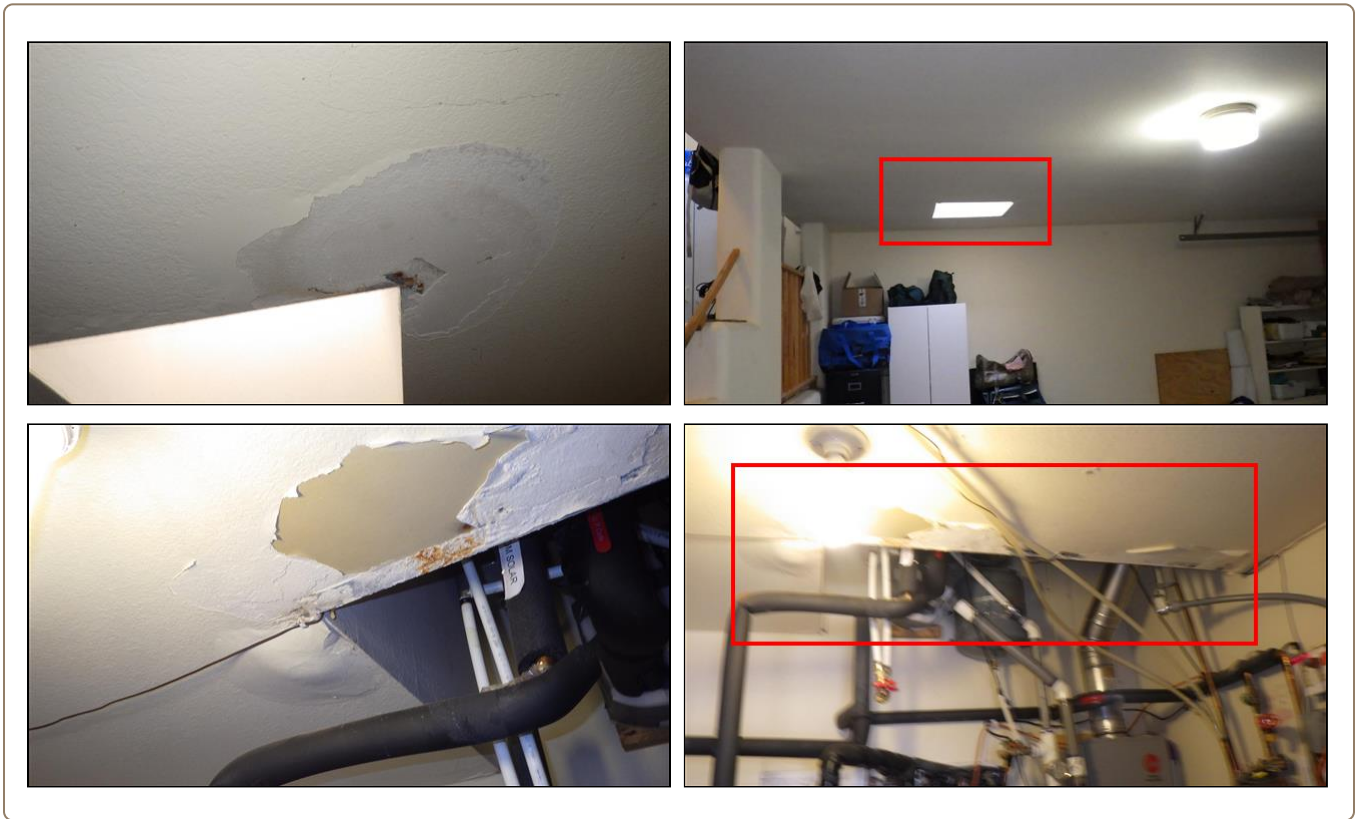
There are drywall cracks along tape lines in the ceiling.

There is evidence of moisture penetration at the ceiling in the form of visible stained, distorted drywall, texture and or paint (noted at the skylight well and above the solar water heating equipment). Further EXAMINATION and ACTION RECOMMENDED as deemed necessary by a QUALIFIED roofing contractor.

After any required roof service is complete, drywall and paint ACTION RECOMMENDED by a QUALIFIED drywall and painting technician.

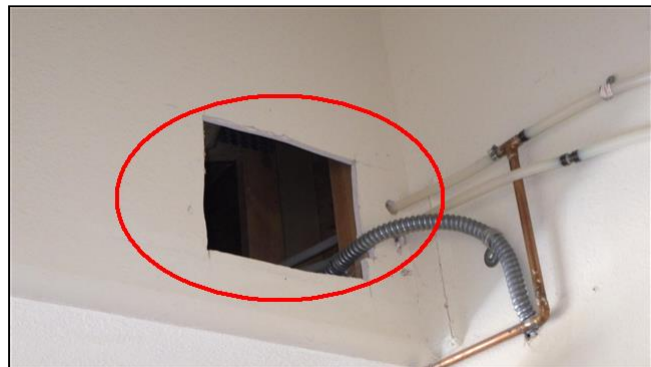
Penetrations and or damage to textured drywall surfaces consistent with those caused by impact from objects and or trades (noted at the garage knee wall near the sunroom). ACTION RECOMMENDED by a QUALIFIED drywall technician.

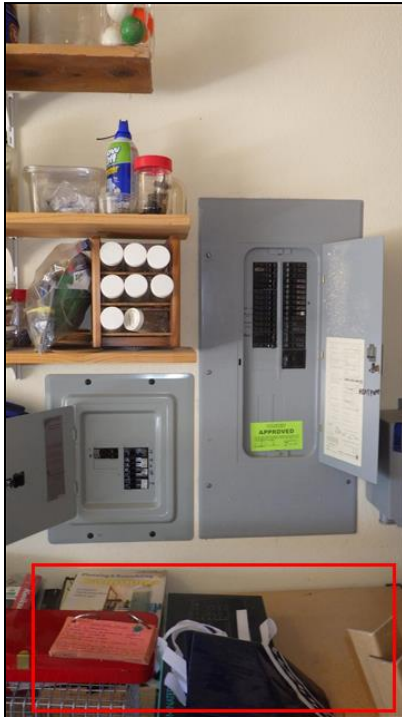
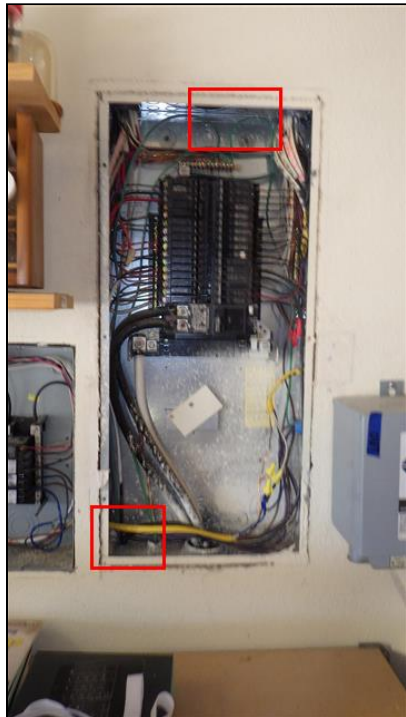
Service access is limited or restricted at a panel (noted at the main distribution panel above the garage work bench). Distribution panels with restricted access should be serviced to meet GENERALLY ESTABLISHED PRACTICES for service access. Electric service panels typically require a minimum of three feet of clear space to the floor directly in front of the panel to access COMPONENTS.

Breaker panel enclosures have voids or open knockouts that can allow access to energized COMPONENTS by pests (noted at the main garage wall distribution panel).

Further EXAMINATION and ACTION RECOMMENDED as deemed necessary by a QUALIFIED electrician.

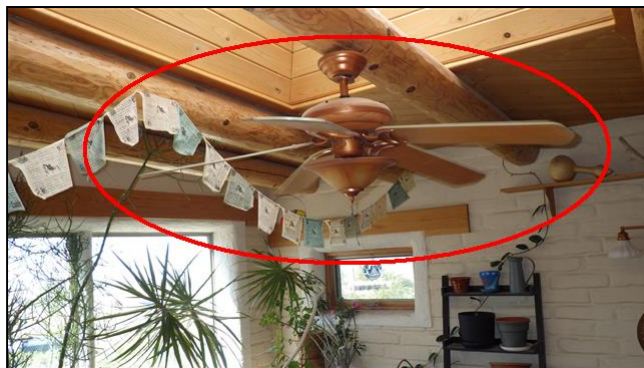
A fan is loose and or out of balance and should be serviced to be secure and run with limited motion (noted in the sunroom).

A ceiling fan is damaged (noted warped blades at the sunroom unit) and should be serviced for repair or replacement.

ACTION RECOMMENDED by a QUALIFIED electrician.

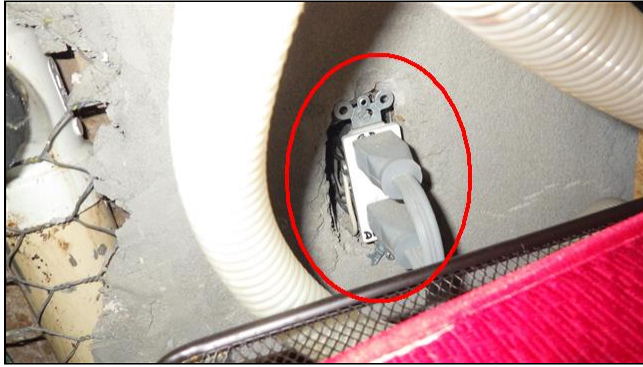
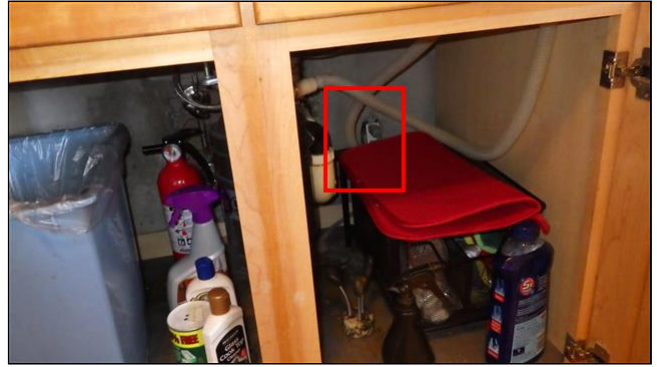
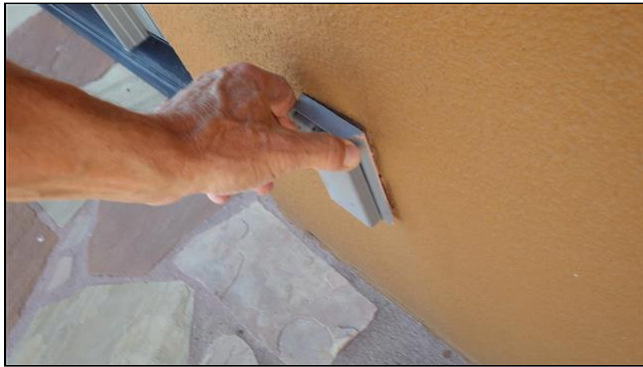
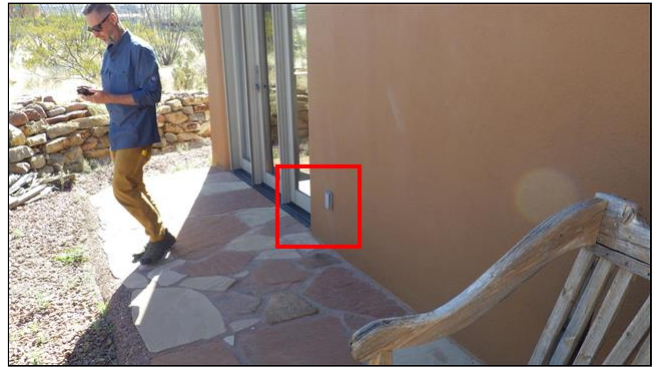
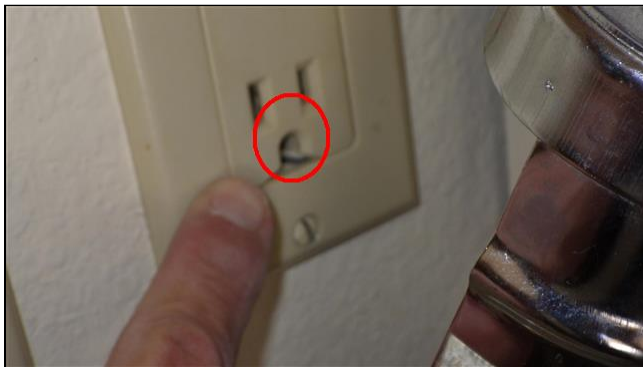
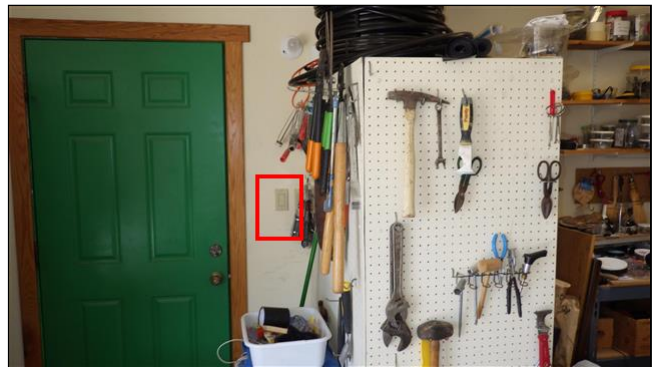
110 volt receptacle and switch plate covers are cracked, broken and or incomplete (noted under the kitchen sink and at the jet tub motor).

110 volt receptacles are loose at wall attachments (noted at the back wall outside the master suite).

A 110 volt receptacle face is cracked (noted at the right of the sunroom door on the garage wall).

ACTION RECOMMENDED by a **QUALIFIED** electrician.

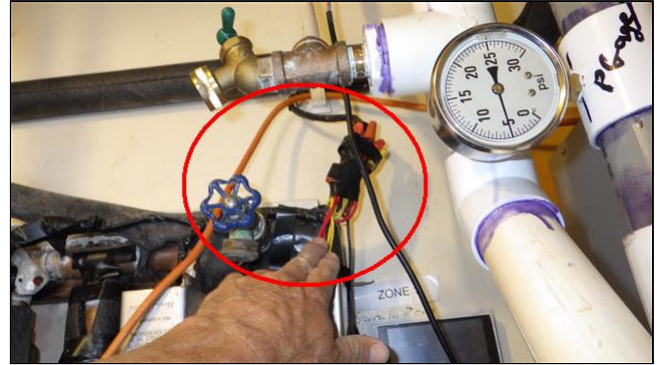
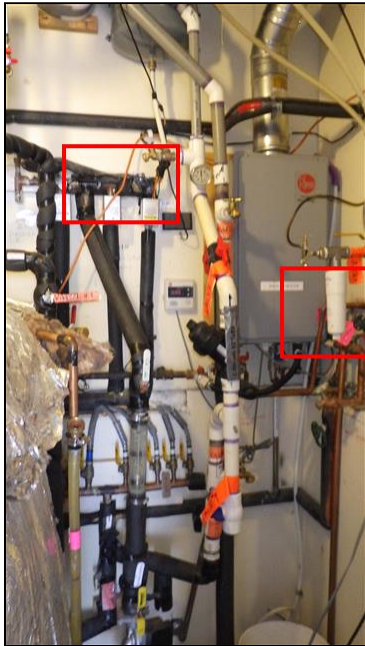
110 volt wiring and connections are not covered or secured at pump and solenoid valve connections (noted at the solar equipment closet). ACTION RECOMMENDED by a QUALIFIED electrician.

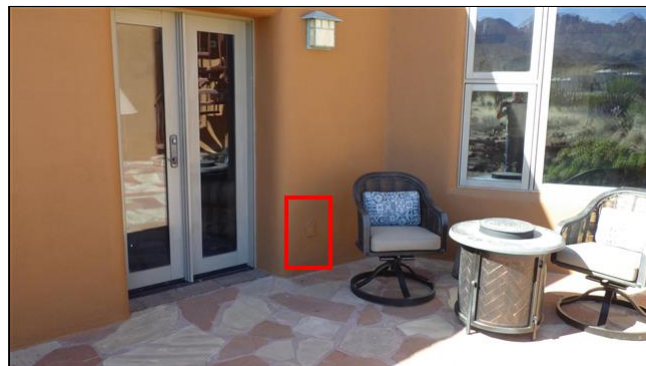
GFCI type outlets will not trip to protect the circuit (noted at the back house wall). ACTION RECOMMENDED by a QUALIFIED electrician.

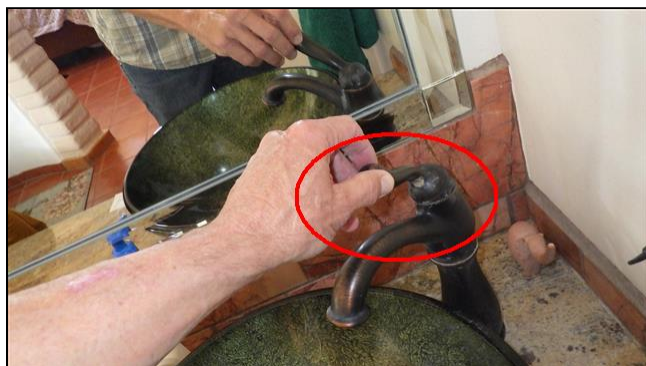
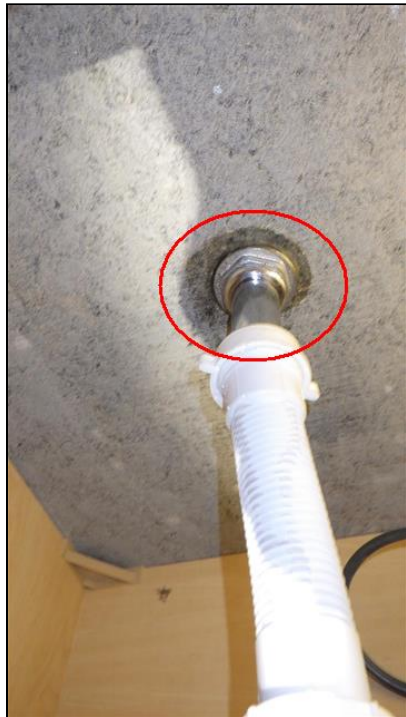
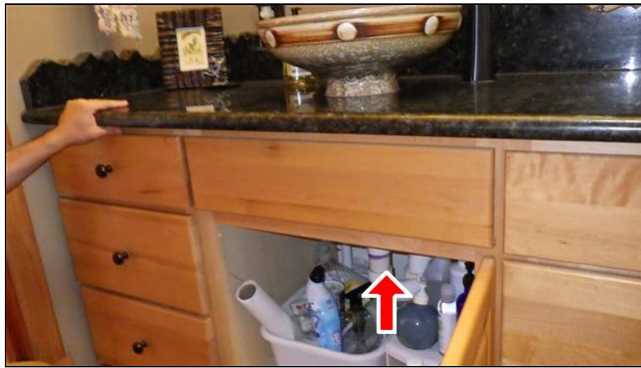
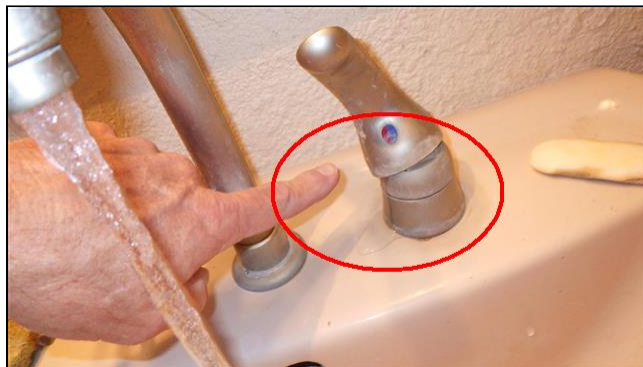
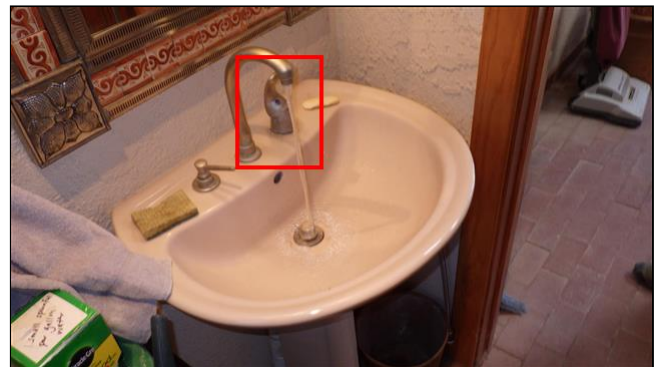
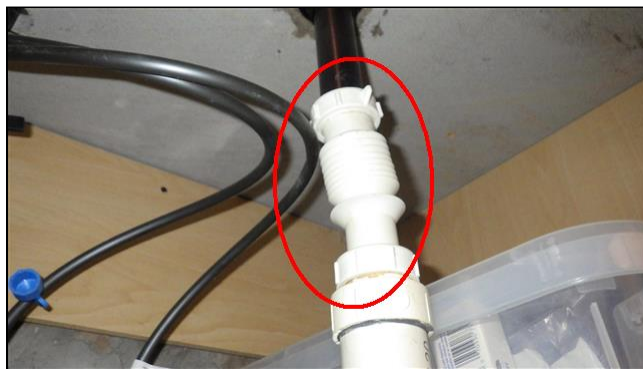
IMPROPER flexible type drain piping installed at sink drains (noted at each master suite sink). Flexible piping should be serviced to meet GENERALLY ESTABLISHED PRACTICES which will typically require installation of smooth wall pipes that drain reliably.

ACTION RECOMMENDED by a QUALIFIED plumber.

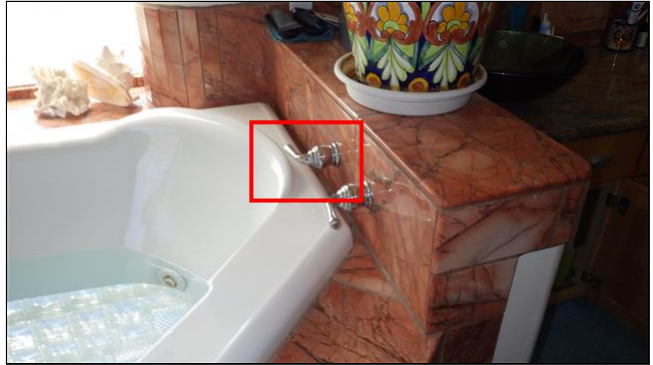
Tub control valves are loose in the wall and or at attachments (noted at the jet tub).

ACTION RECOMMENDED by a QUALIFIED plumber.

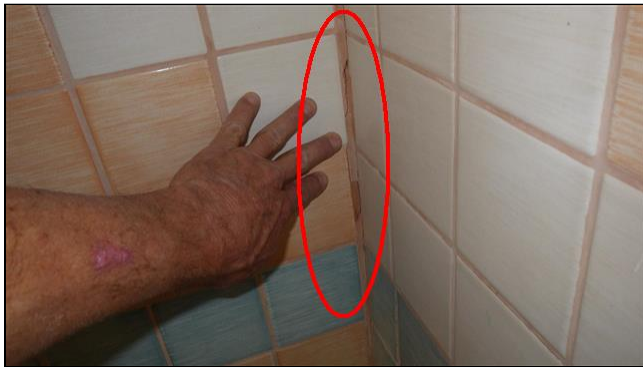
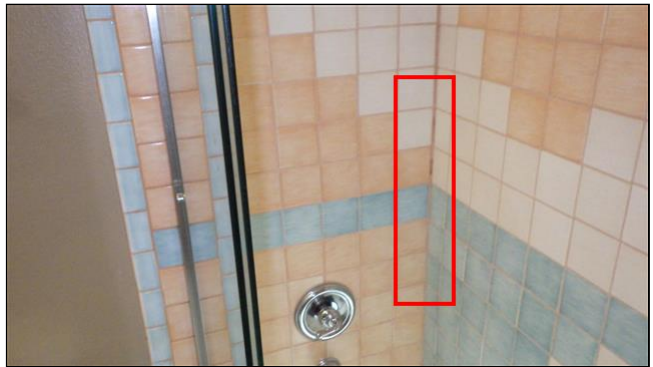
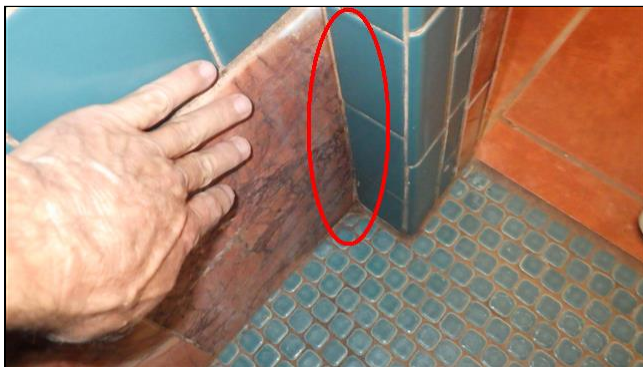
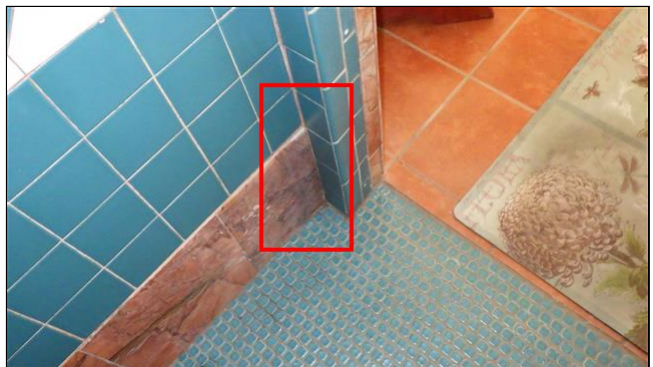
(2) There are separated and or open grout-joints in the tiled stall showers. ACTION RECOMMENDED by a QUALIFIED tile installation contractor.

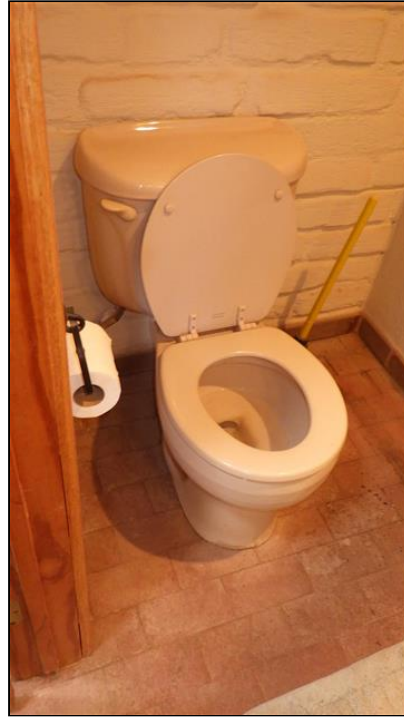
A toilet is loose at its bolted attachment to the floor and should be serviced to be secure and leak free (noted at the sunroom bathroom). ACTION RECOMMENDED by a QUALIFIED plumber.

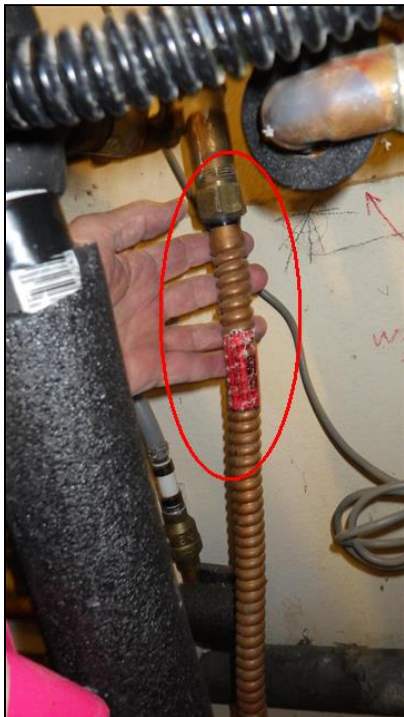
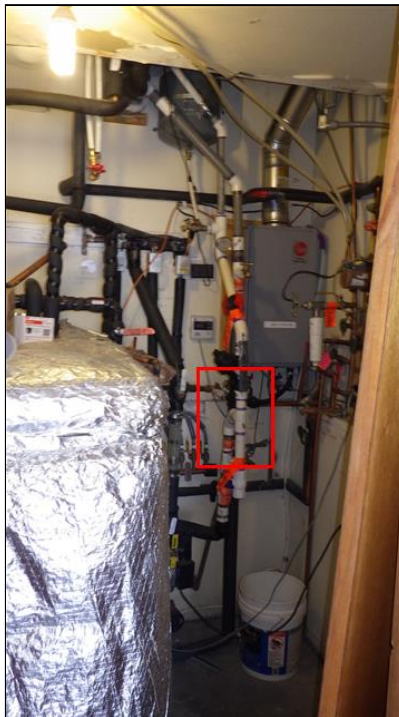
IMPROPER reduction of the Temperature and Pressure Relief drain line was noted at the water heater/boiler connection to the TPR valve. Further EXAMINATION and ACTION RECOMMENDED as deemed necessary by a QUALIFIED plumbing contractor.

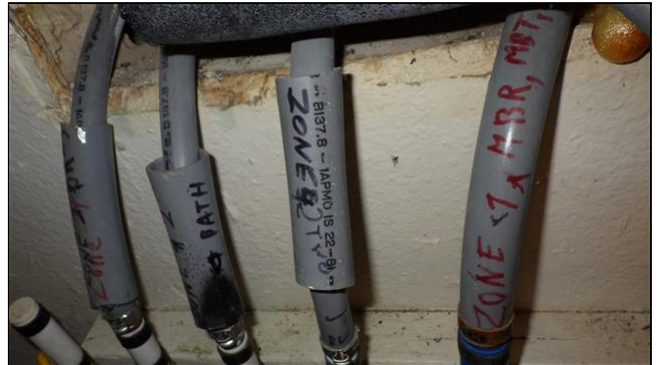
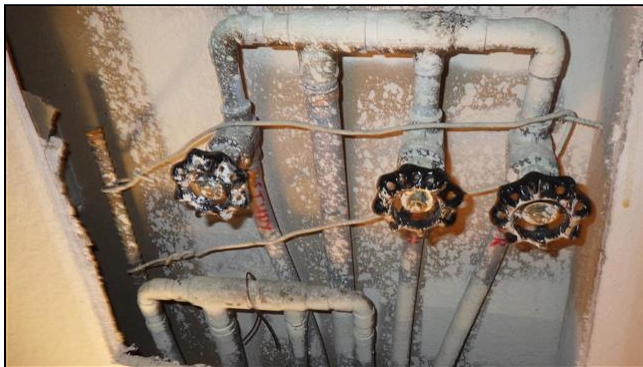
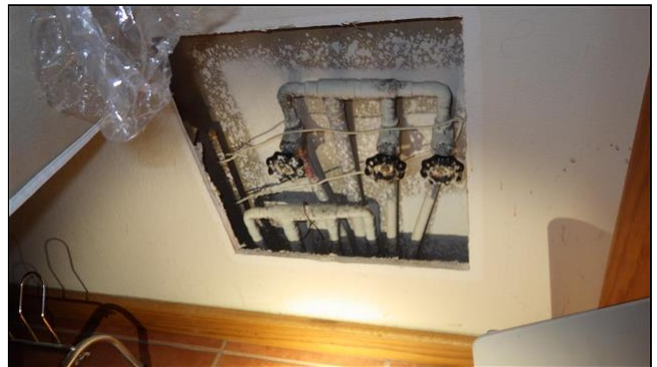
The in floor/slab recirculation piping installed is a plastic poly-butylene (PB) material (visible at the solar equipment closet and at the master bedroom closet valve manifolds). This piping material and it's fittings have a history of failure in residential potable water distribution applications. Additionally, PB piping has no oxygen barrier, and this can lead to corrosion of metal surfaces in pumps, boilers and valves for in-floor recirculated SYSTEMS. This PB piping installation and radiant heating/cooling SYSTEM should have further EXAMINATION by a QUALIFIED radiant floor installation and service contractor. Any service required after their INSPECTION should be completed by a QUALIFIED contractor.

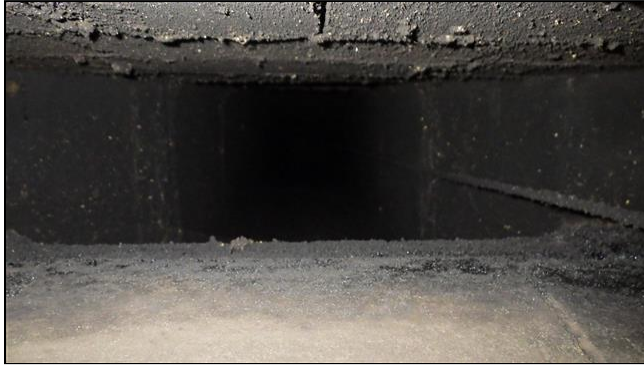
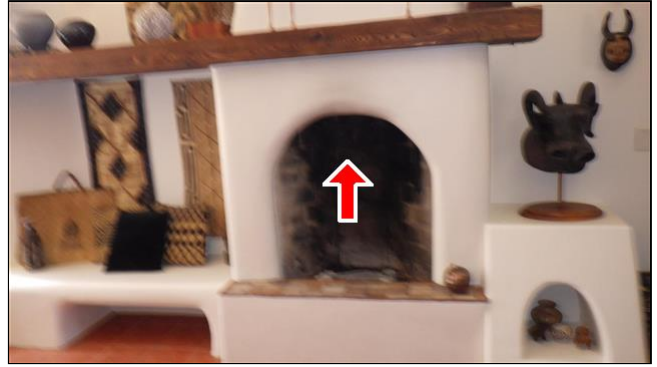
Typical accumulation of soot and creosote deposits at the fireplace flue and firebox were noted. ROUTINE MAINTENANCE should be provided by a QUALIFIED chimney sweep or fireplace technician.

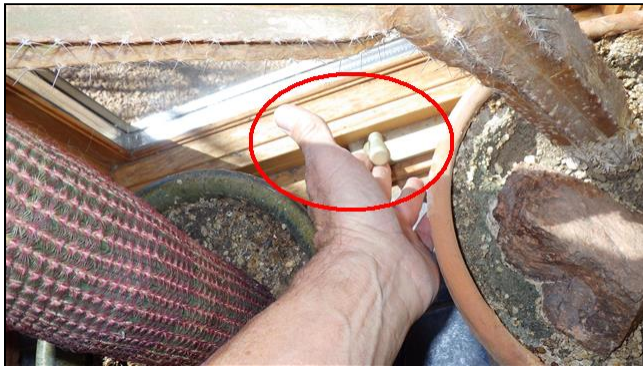
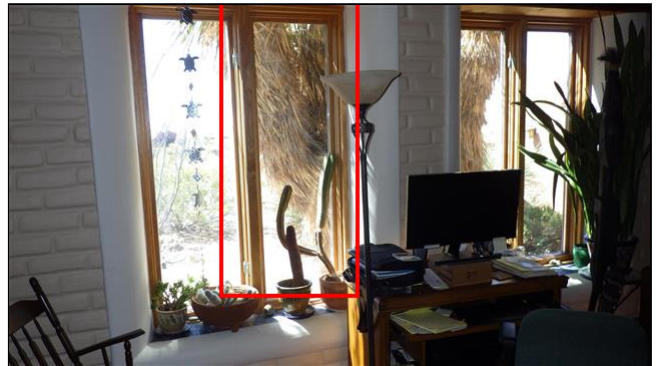
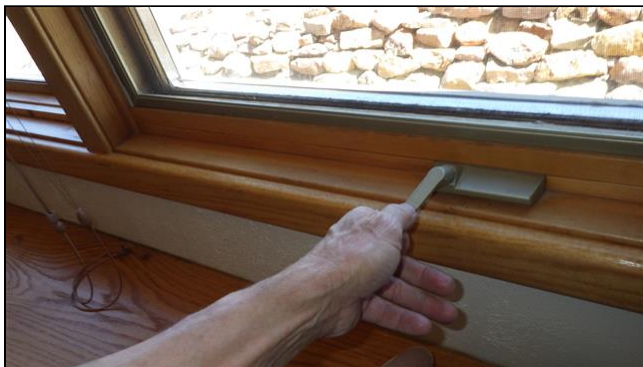
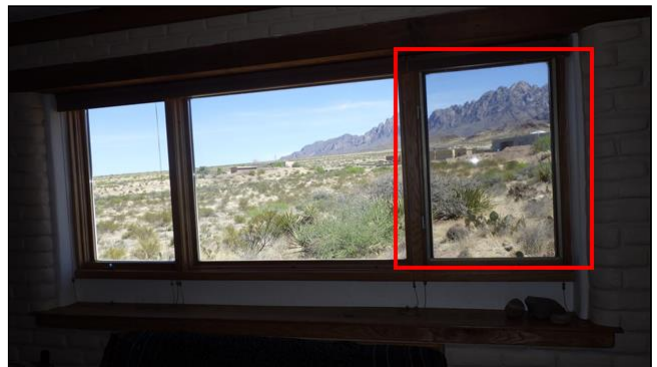
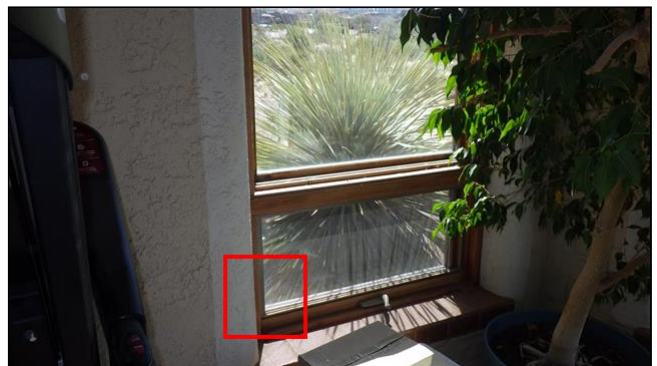
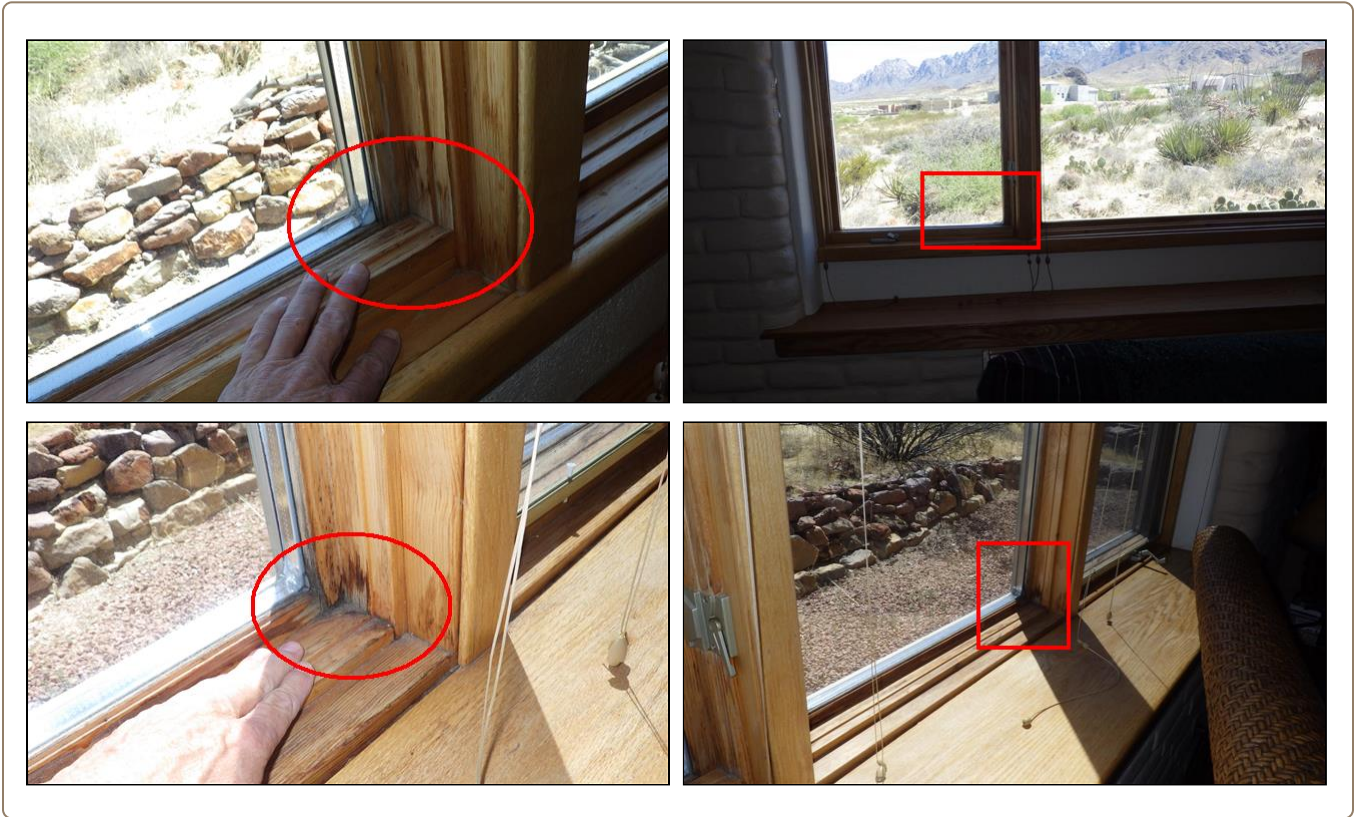
Insect screens are missing at a number of windows.

Each window in the home should have further EXAMINATION and ACTION RECOMMENDED as deemed necessary by a QUALIFIED window repair contractor.

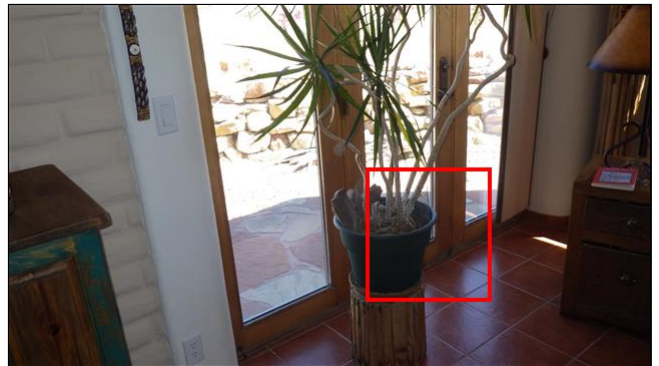
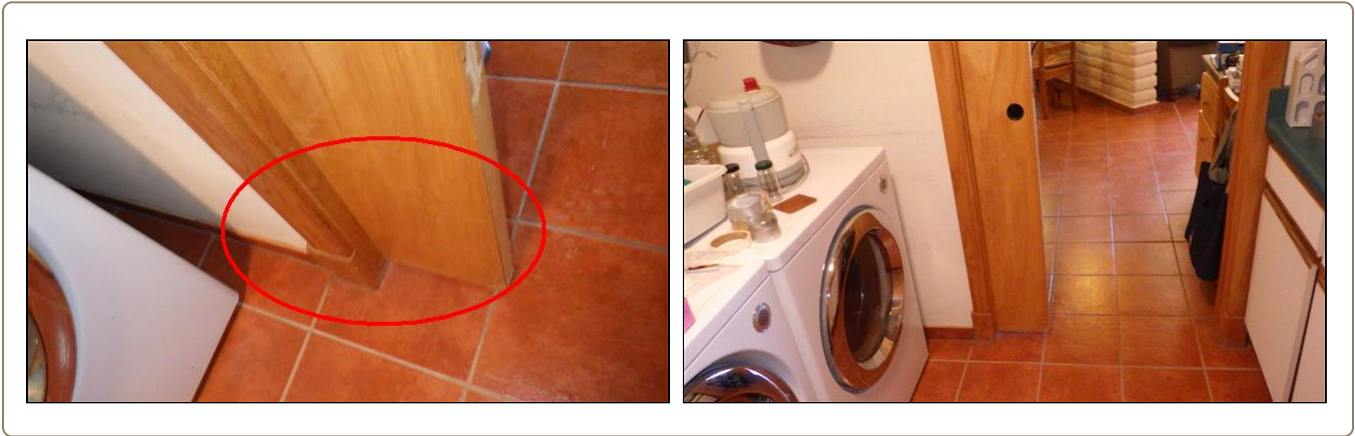
Pocket doors interfere and or rub at the wall jamb opening (noted at the laundry room).

Further EXAMINATION and ACTION RECOMMENDED as deemed necessary by a QUALIFIED carpenter.

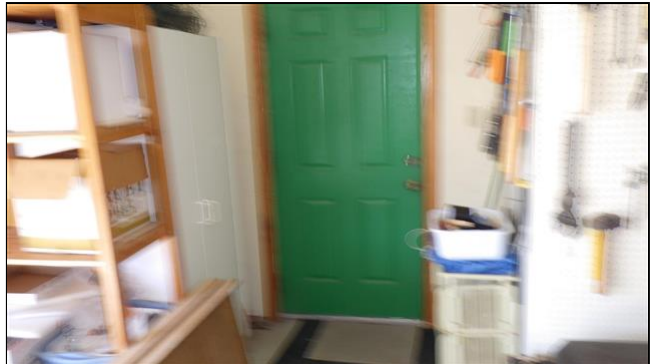
Latches do not reliably secure exterior doors (noted at the garage to sunroom door). ACTION RECOMMENDED by a QUALIFIED carpenter.

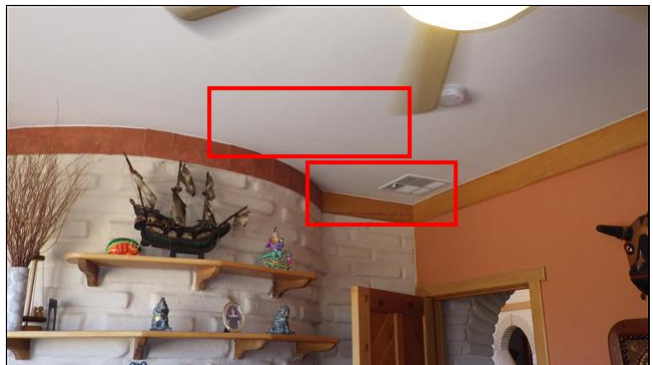
(1) There is moisture impact to the ceiling in the form of stains and or distorted drywall finish consistent with movement of water through the roof deck from precipitation (noted at the back guest bedroom). These areas should be documented as stabilized by known repairs from a QUALIFIED technician or the roof SYSTEM should be serviced by a QUALIFIED roofing contractor. After leakage issues are stabilized, damaged drywall and paint should be serviced by a QUALIFIED drywall and painting technician.

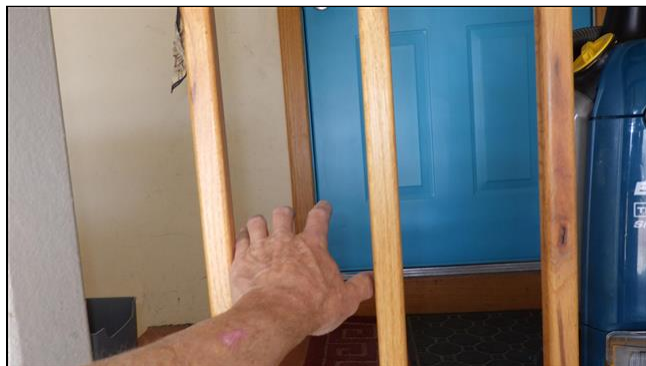
Handrails at stairs do not return to the wall (noted at the garage). Rail ends gapped from the wall should be serviced to limit risk of hang ups on clothing and or purse straps.

ACTION RECOMMENDED by a QUALIFIED carpenter.
