Inspection Report

Box 101
Texasville TX 76000

Inspection Connection LC

PROPERTY INSPECTION REPORT FORM

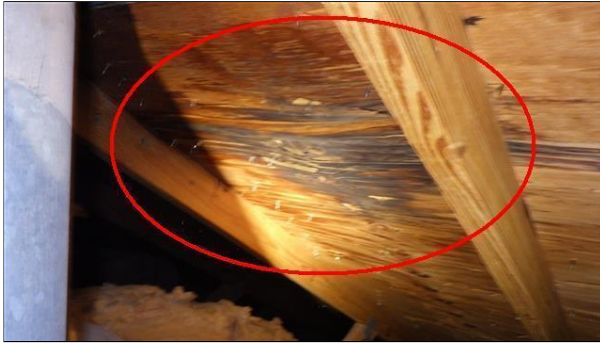
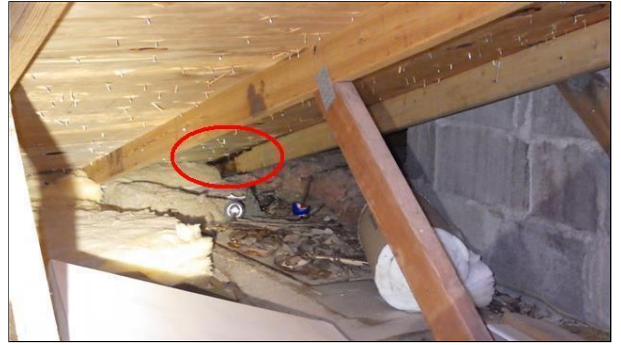
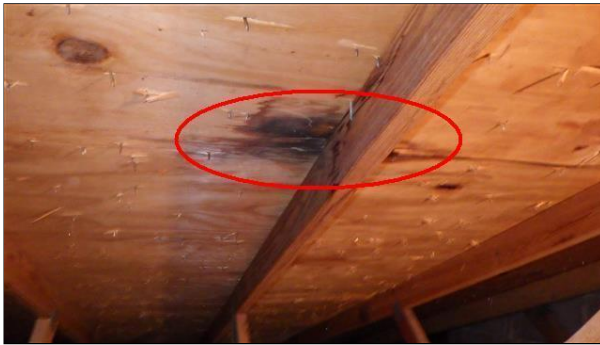
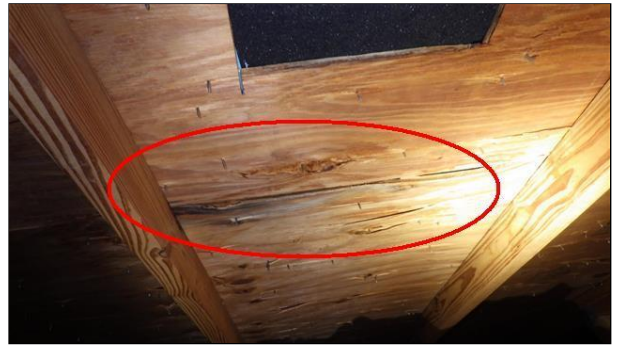
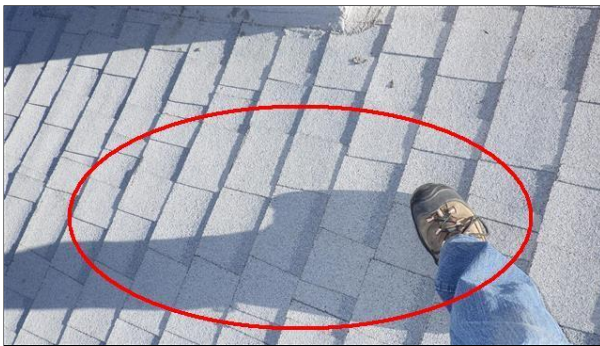
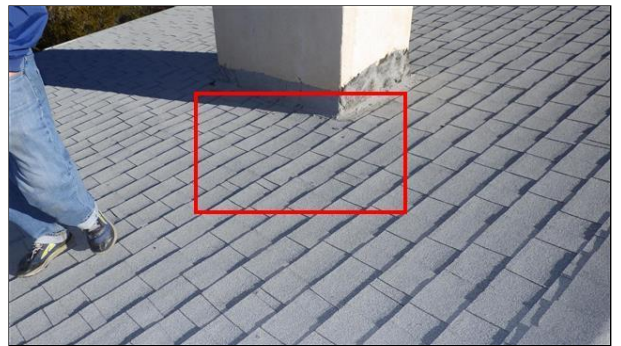
Roof deck is moisture damaged and or rotted at points (noted at plywood deck areas above the garage and below the passive attic roof deck vents).

Plywood roof decking is soft and or deflects under foot consistent with deterioration or damage to underlying wood or wood composite decking due to moisture (noted near the chimney above the garage).

Further EXAMINATION and ACTION RECOMMENDED as required for repair by a QUALIFIED carpenter and or roofing contractor.

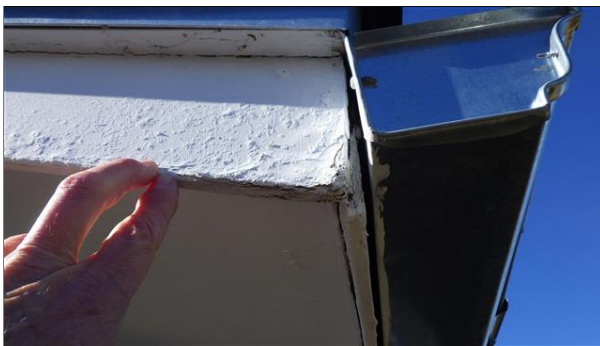
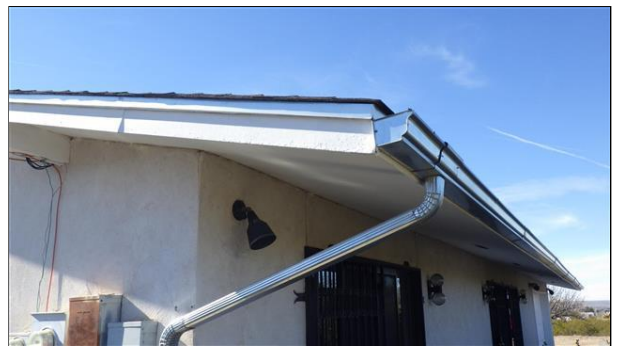
(2) Roof eave fascia and or soffit has moisture damage and or wood rot (noted at a limited area on the composite fascia for the front right house side corner). ACTION RECOMMENDED by a QUALIFIED carpenter.

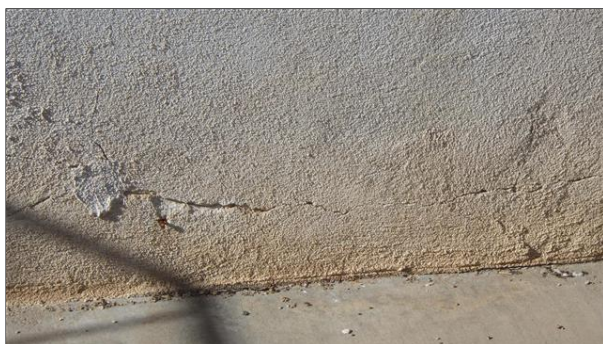
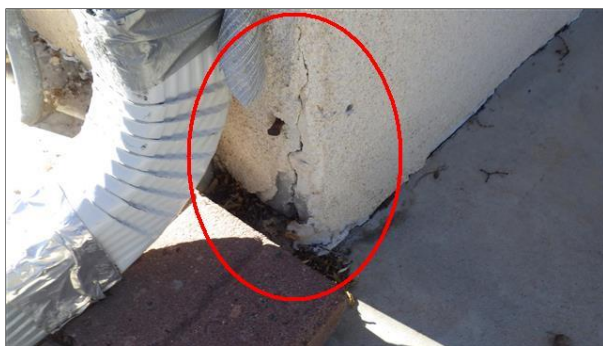
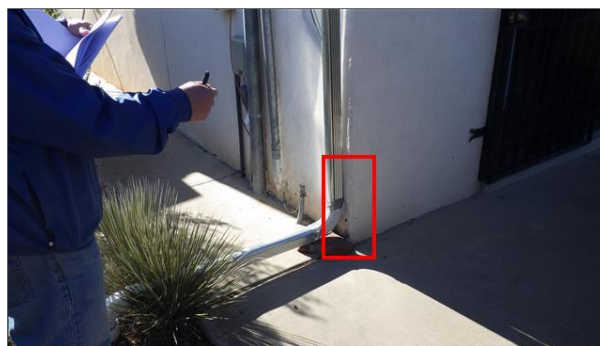
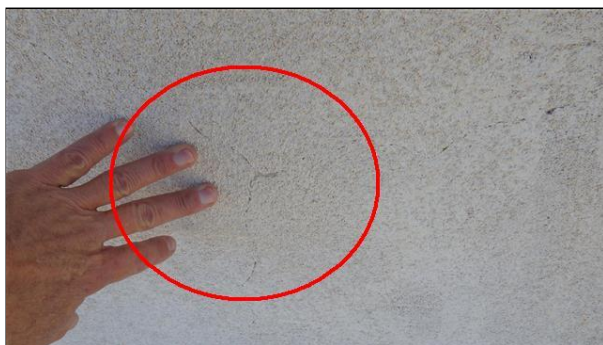
The stucco color coat is spalding (wearing away or delaminating) and or cracking near the grade as a result of moisture near the ground in areas at the perimeter of the home.

There are cracks in the stucco at corners, control joints and or adjacent to windows and doors

Fine cracks and or lines at the stucco color coat surface noted in the field of the exterior walls. These cracks allow moisture to impact the grey/ bond coat of stucco beneath the color coat.

All stucco covered wall areas should have further EXAMINATION and ACTION RECOMMENDED as deemed necessary by a QUALIFIED stucco contractor.

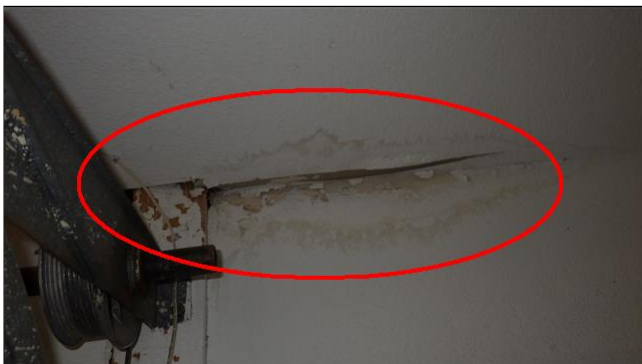
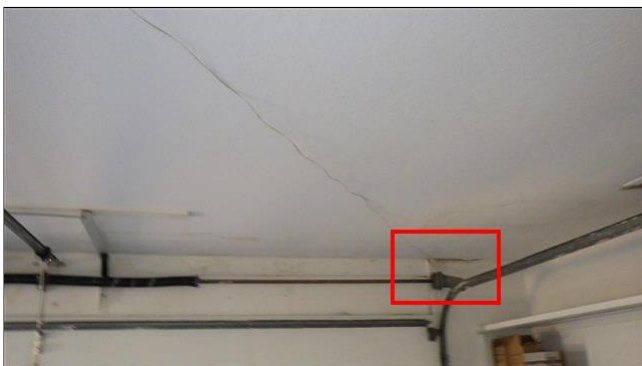
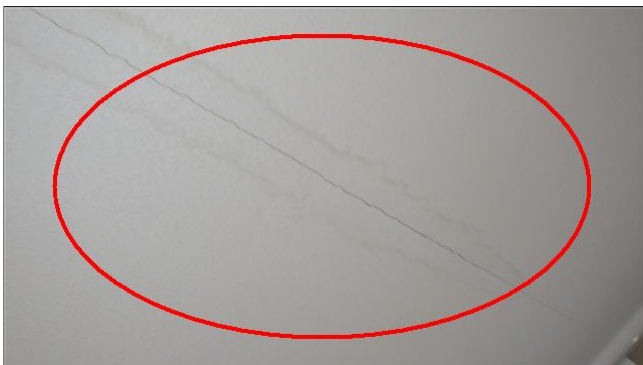
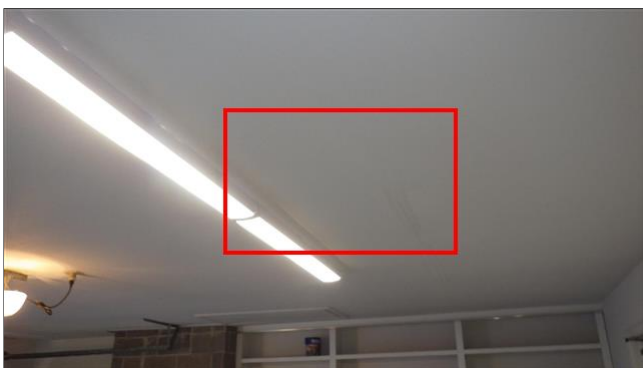
There is evidence of moisture penetration at the ceiling in the form of visible stained, distorted drywall, texture and or paint (noted at the garage). Further EXAMINATION and ACTION RECOMMENDED as deemed necessary by a QUALIFIED roofing contractor.

After any required roof service is complete, drywall and paint ACTION RECOMMENDED by a QUALIFIED drywall and painting technician.

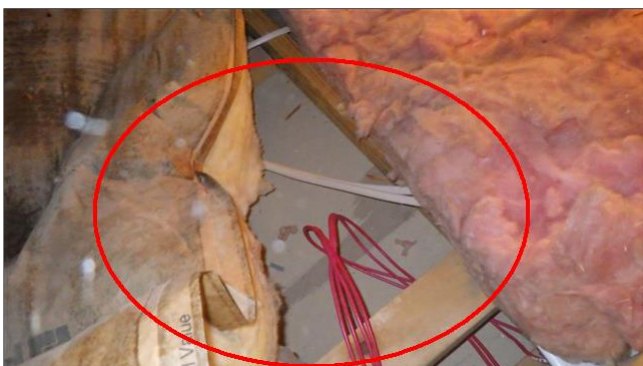
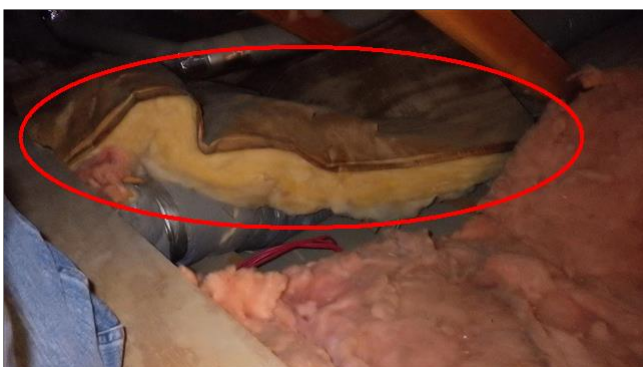
(2) Areas of the attic floor opposite conditioned home spaces with incomplete and or IMPROPER insulation installation (noted incomplete insulation above the hall bathroom and batt insulation not in contact with the ceiling drywall above all home areas). ACTION RECOMMENDED by a QUALIFIED insulation installation contractor.

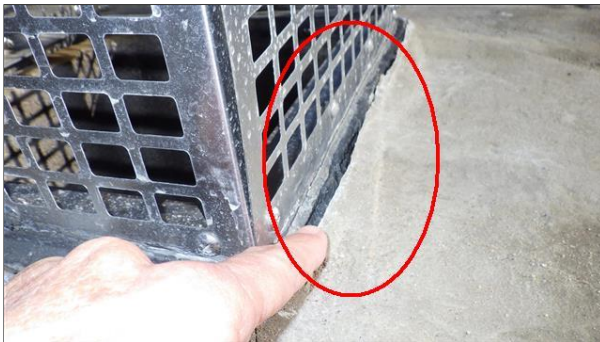
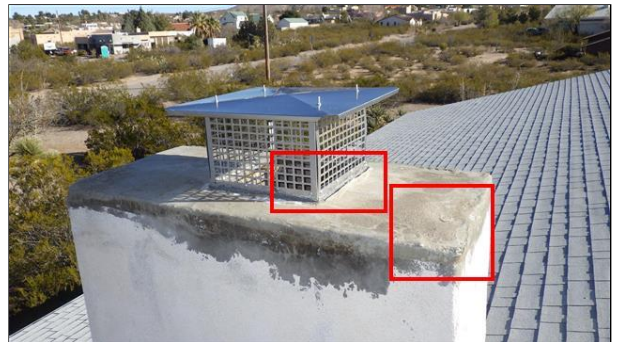
Concrete or mortar cap at the chimney surface and or edges is cracked and or incomplete and can allow water entry. ACTION RECOMMENDED by a QUALIFIED mason.

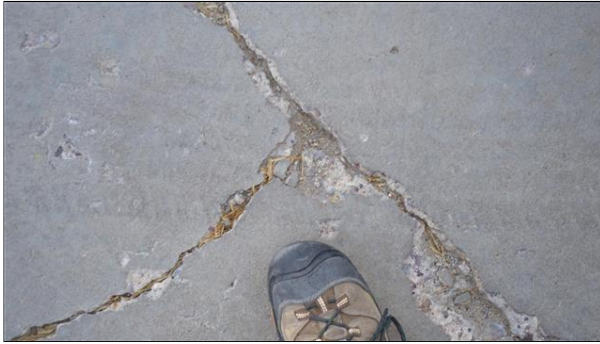
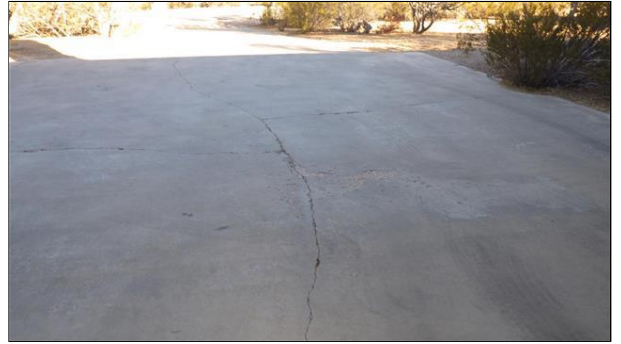
Cracks at concrete slabs with limited differential change in surface height should be serviced to seal

against and limit future moisture and freeze/ thaw impact (noted at the driveway). ACTION RECOMMENDED by a QUALIFIED concrete repair/installation technician.

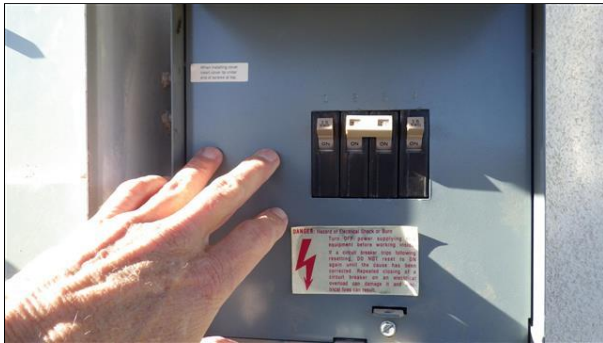
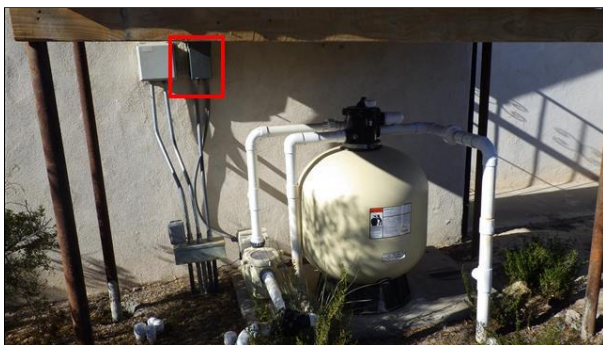
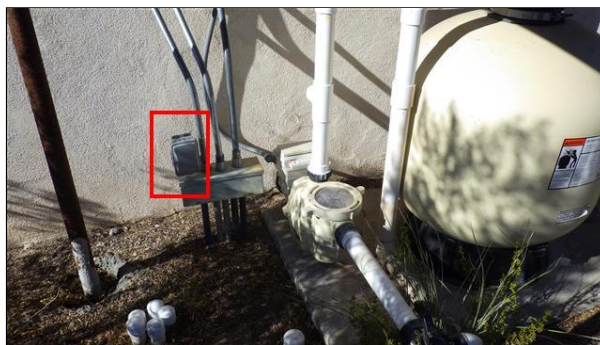
(1) Breakers are not labeled and or labeling is incomplete at a switch and or disconnect panel (noted at the right house side wall pool equipment panel). Individual breakers should be identified and labeled to provide safe and quick disconnect for each area served in the home.

Conductors are "jumped" and or atypically connected to the distribution lugs of the main service breaker in the main switch disconnect panel and have no device to regulate for overload protection.

Individual breakers were noted in the off position and the SYSTEM or COMPONENT serviced was NOT EXAMINED (noted at the pool equipment and pump breaker switch).

Exterior receptacles have no power (noted at the pool equipment area).

Kitchen receptacles are not Ground Fault Interrupted. Service by a QUALIFIED electrician is recommended to have GFCI type receptacles installed at these areas as an ELECTIVE MODIFICATION.

Further EXAMINATION and ACTION RECOMMENDED as deemed necessary by a QUALIFIED electrician.

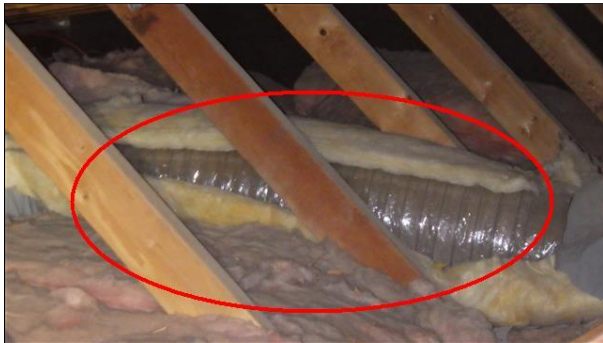
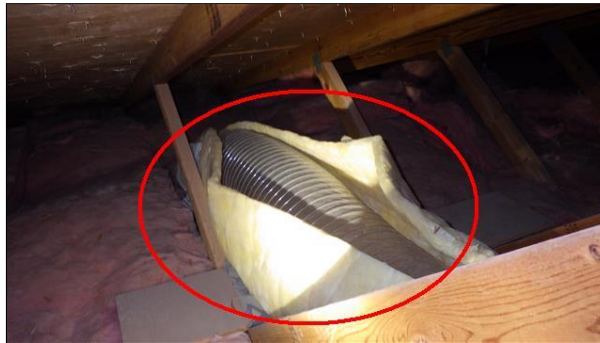
(1) Insulation wrap is deteriorated, missing or incomplete at flex duct sections (noted at each flex run in the attic). This 1980 - 90's vintage flex ductwork originally included a grey colored plastic type wrap that has proven to be defective and often is damaged by UV radiation in the attic space. Further EXAMINATION and ACTION RECOMMENDED as deemed necessary by a QUALIFIED HVAC contractor.

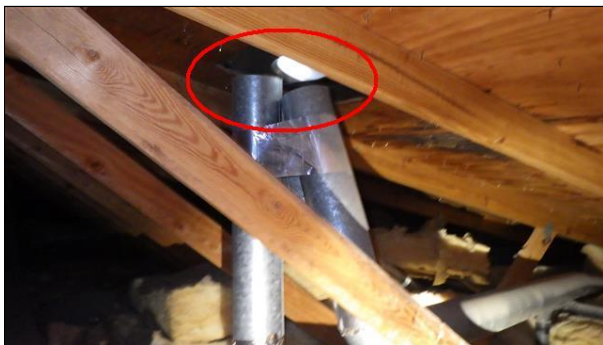
(2) Ventilation ducting is loose and or disconnected within the attic space (noted at each bath fan exhaust duct that terminates in the attic) and should be serviced to extend to a weather protect outlet at the roof or exterior soffit. ACTION RECOMMENDED by a QUALIFIED hvac technician.

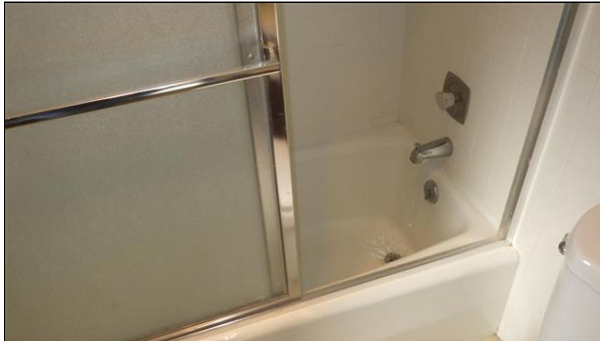
Drains are slow or blocked (noted at the master suite tub). ACTION RECOMMEND by a QUALIFIED plumber.

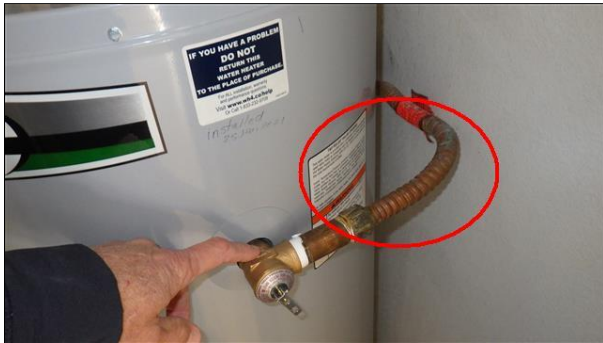
IMPROPER reduction of the Temperature and Pressure Relief drain line was noted at the connection to the TPR valve. Further EXAMINATION and ACTION RECOMMENDED as deemed necessary by a QUALIFIED plumbing contractor.
