Inspection Report

**New Mexico
Homebuyer**

Property Address:
1234 Camino St.
Las Cruces NM 88001

Date: 4/20/2022	Time: 08:35 AM	Report ID: Sample
Property: Las Cruces NM 88011	Customer: NM Homebuyer	Real Estate Professional: Best in LC

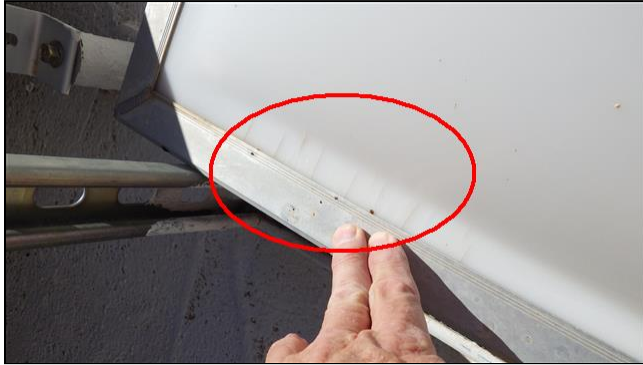
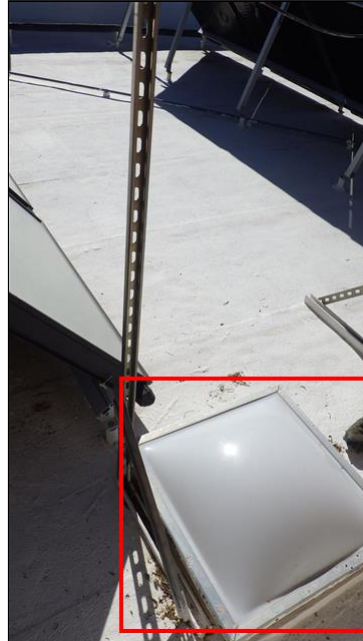
Exterior plastic lens of dual glazed skylights are fractured (noted near the solar water heating panels and above the kitchen). ACTION RECOMMENDED by a QUALIFIED roofing contractor.

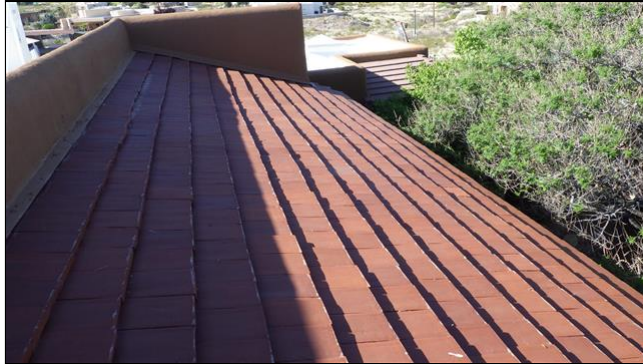
Tiles or mortar are cracked and or loose (noted at limited areas on the clay tile patio roof). ACTION RECOMMENDED by a QUALIFIED roofing contractor.

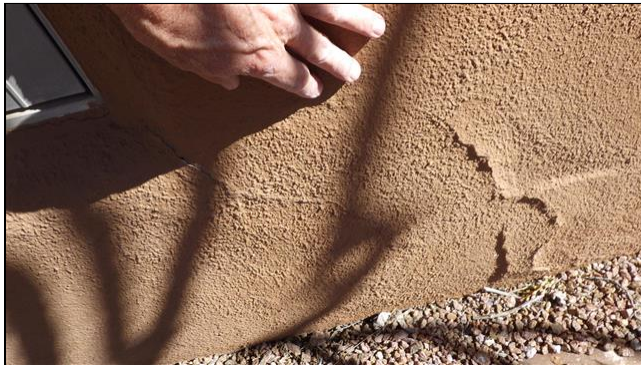
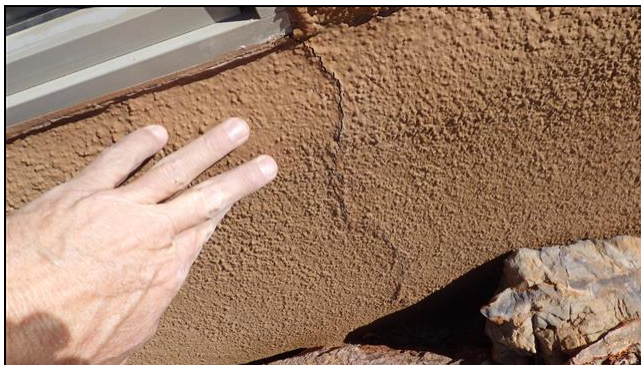
There are cracks in the stucco at corners, control joints and or adjacent to windows and doors. All stucco covered wall areas should have further EXAMINATION and ACTION RECOMMENDED as deemed necessary by a QUALIFIED stucco contractor.

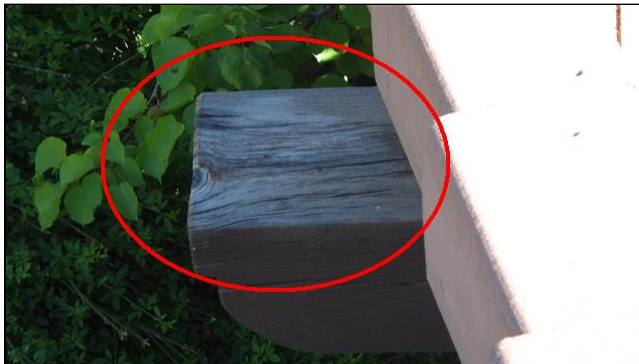
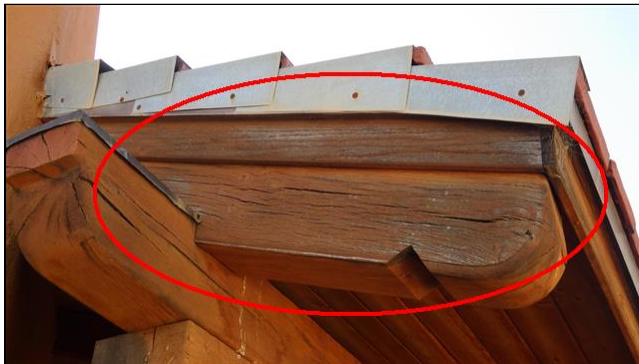
(1) Weathered wood surfaces at posts and beams (noted at exposed wood areas for each patio) should be serviced to be sealed and or moisture protected. ACTION RECOMMENDED by a QUALIFIED painter

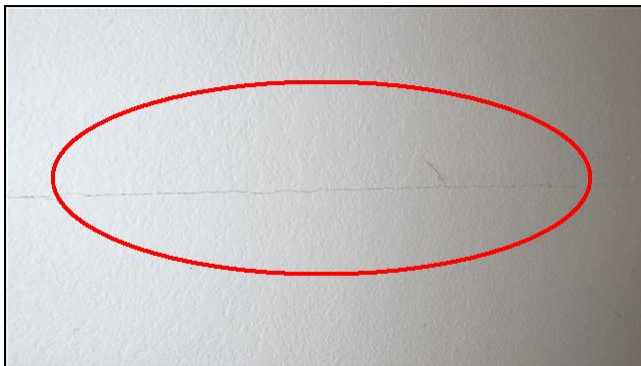
There is evidence of moisture penetration at the ceiling in the form of visible stained, distorted drywall, texture and or paint (noted at the skylight well and above the solar water heating equipment). Further EXAMINATION and ACTION RECOMMENDED as deemed necessary by a QUALIFIED roofing contractor.

After any required roof service is complete, drywall and paint ACTION RECOMMENDED by a QUALIFIED drywall and painting technician.

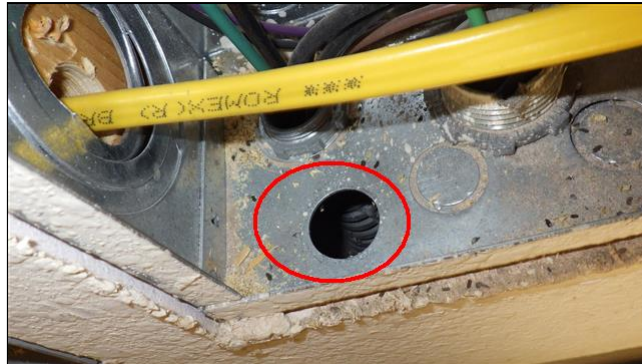
Breaker panel enclosures have voids or open knockouts that can allow access to energized COMPONENTS by pests (noted at the main garage wall distribution panel).

Further EXAMINATION and ACTION RECOMMENDED as deemed necessary by a QUALIFIED electrician.

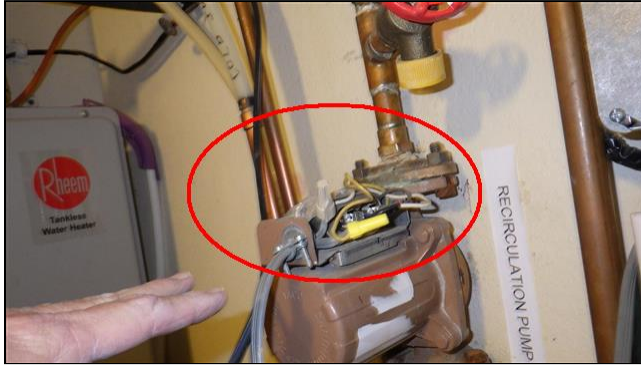
110 volt wiring and connections are not covered or secured at pump and solenoid valve connections (noted at the solar equipment closet). ACTION RECOMMENDED by a QUALIFIED electrician.

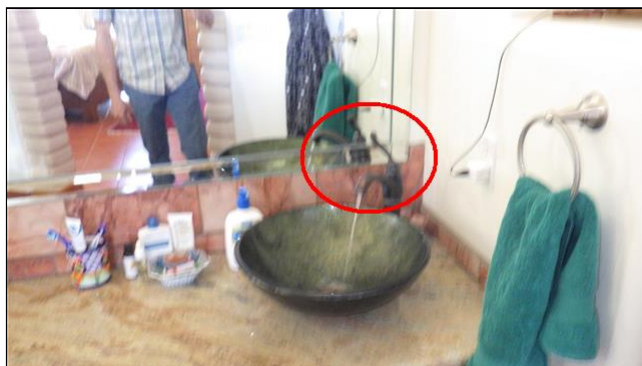
IMPROPER flexible type drain piping installed at sink drains (noted at each master suite sink). Flexible piping should be serviced to meet GENERALLY ESTABLISHED PRACTICES which will typically require installation of smooth wall pipes that drain reliably.

ACTION RECOMMENDED by a QUALIFIED plumber.

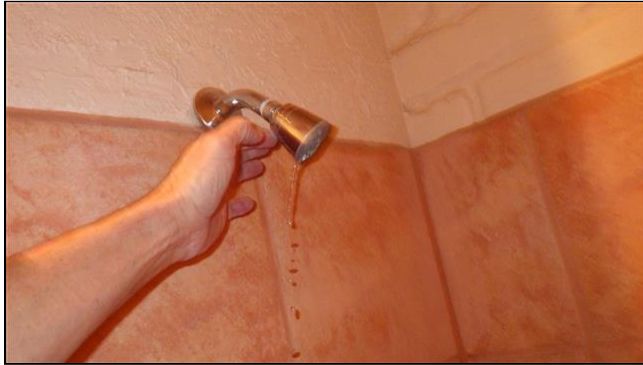
Tub control valves are loose in the wall and or at attachments (noted at the jet tub).

ACTION RECOMMENDED by a QUALIFIED plumber.

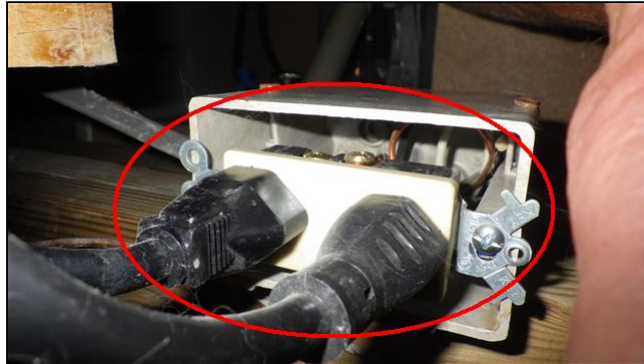
The jet tub pump motor electric receptacle is not Ground Fault Circuit Interrupter protected by a READILY ACCESSIBLE GFCI breaker or receptacle. ACTION RECOMMENDED by a QUALIFIED electrician.

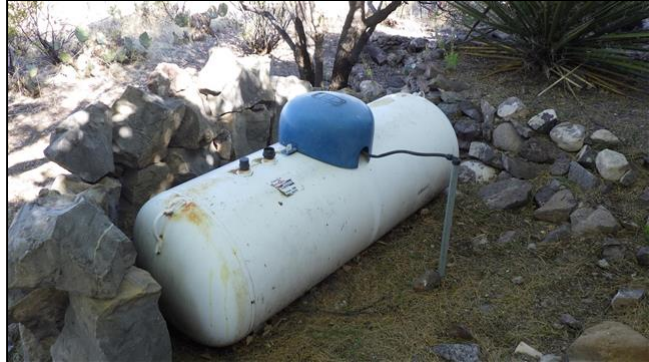
The property is serviced by a propane gas storage and supply SYSTEM. Area propane service providers and local, state and national regulatory organizations enforce specific rules on the positioning, maintenance and service of propane storage vessels and a complete evaluation of the propane tank installation is beyond the scope of this inspection. The propane supply and storage SYSTEM should be EXAMINED by your chosen propane gas supplier to insure that the property can be serviced.

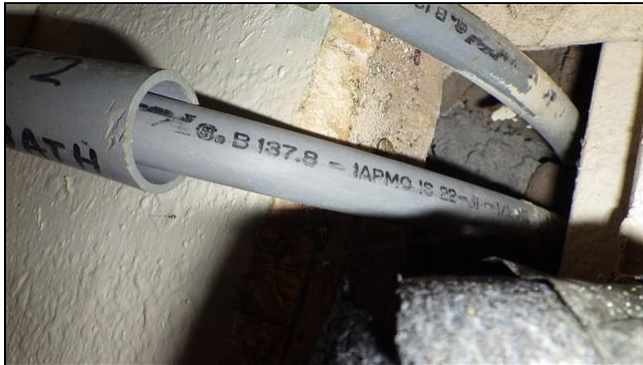
The in floor/slab recirculation piping installed is a plastic poly-butylene (PB) material (visible at the solar equipment closet and at the master bedroom closet valve manifolds). This piping material and it's fittings have a history of failure in residential potable water distribution applications. Additionally, PB piping has no oxygen barrier, and this can lead to corrosion of metal surfaces in pumps, boilers and valves for in-floor recirculated SYSTEMS. This PB piping installation and radiant heating/cooling SYSTEM should have further EXAMINATION by a QUALIFIED radiant floor installation and service contractor. Any service required after their INSPECTION should be completed by a QUALIFIED contractor.

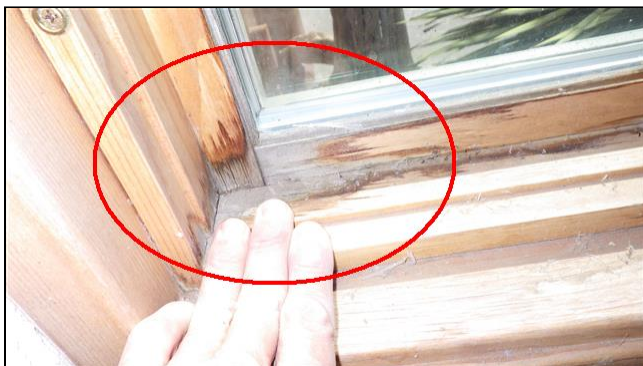
Insect screens are missing at a number of windows.

Each window in the home should have further EXAMINATION and ACTION RECOMMENDED as deemed necessary by a QUALIFIED window repair contractor.

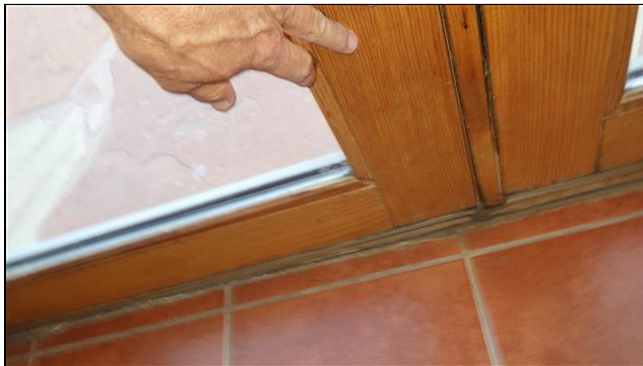
Pocket doors interfere and or rub at the wall jamb opening (noted at the laundry room).

Further EXAMINATION and ACTION RECOMMENDED as deemed necessary by a QUALIFIED carpenter.

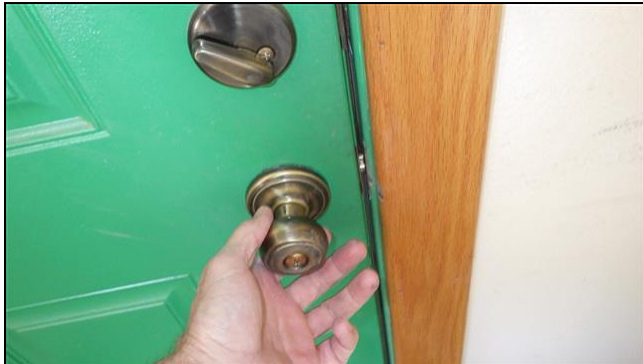
Latches do not reliably secure exterior doors (noted at the garage to sunroom door). ACTION RECOMMENDED by a QUALIFIED carpenter.

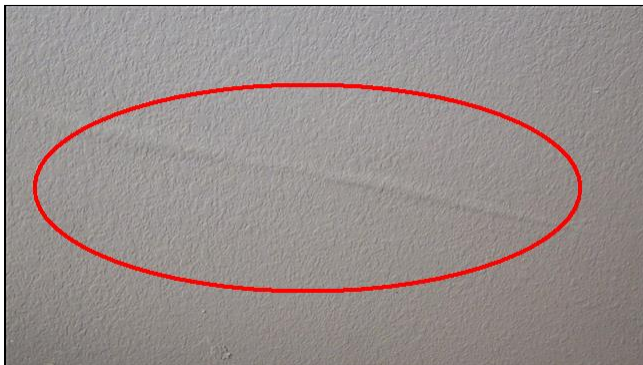
(1) There is moisture impact to the ceiling in the form of stains and or distorted drywall finish consistent with movement of water through the roof deck from precipitation (noted at the back guest bedroom). These areas should be documented as stabilized by known repairs from a QUALIFIED technician or the roof SYSTEM should be serviced by a QUALIFIED roofing contractor. After leakage issues are stabilized, damaged drywall and paint should be serviced by a QUALIFIED drywall and painting technician.

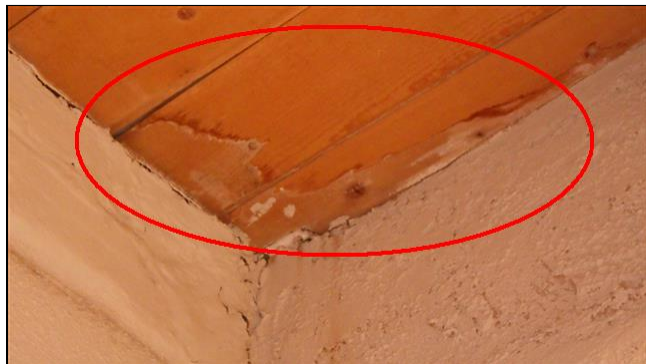
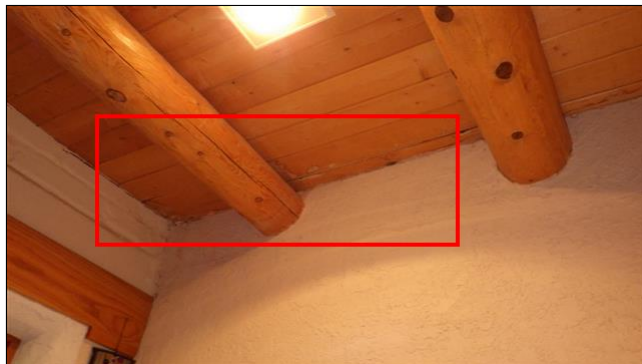
(2) There is moisture impact to the ceiling in the form of stains and or distorted wood COMPONENTS consistent with movement of water movement through the roof deck from precipitation (noted at the sunroom bathroom). These areas should be documented as stabilized by known repairs from a QUALIFIED technician or the roof SYSTEM should be serviced by a QUALIFIED roofing contractor.

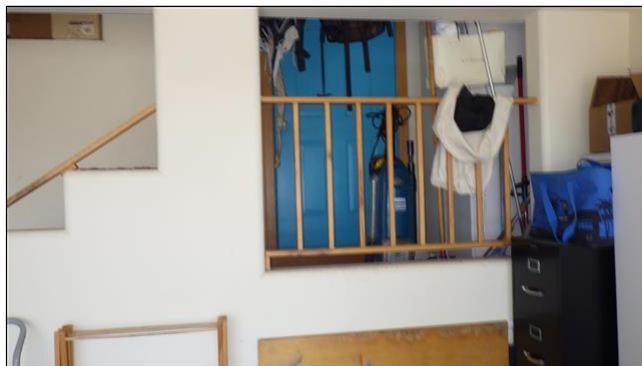
Handrails at stairs do not return to the wall (noted at the garage). Rail ends gapped from the wall should be serviced to limit risk of hang ups on clothing and or purse straps.

ACTION RECOMMENDED by a QUALIFIED carpenter.
